Division of Marine Fisheries

Annual Report to Buzzards Bay Coalition

Eelgrass Surveys for Wareham Wastewater Treatment Plant Project

2018-2019

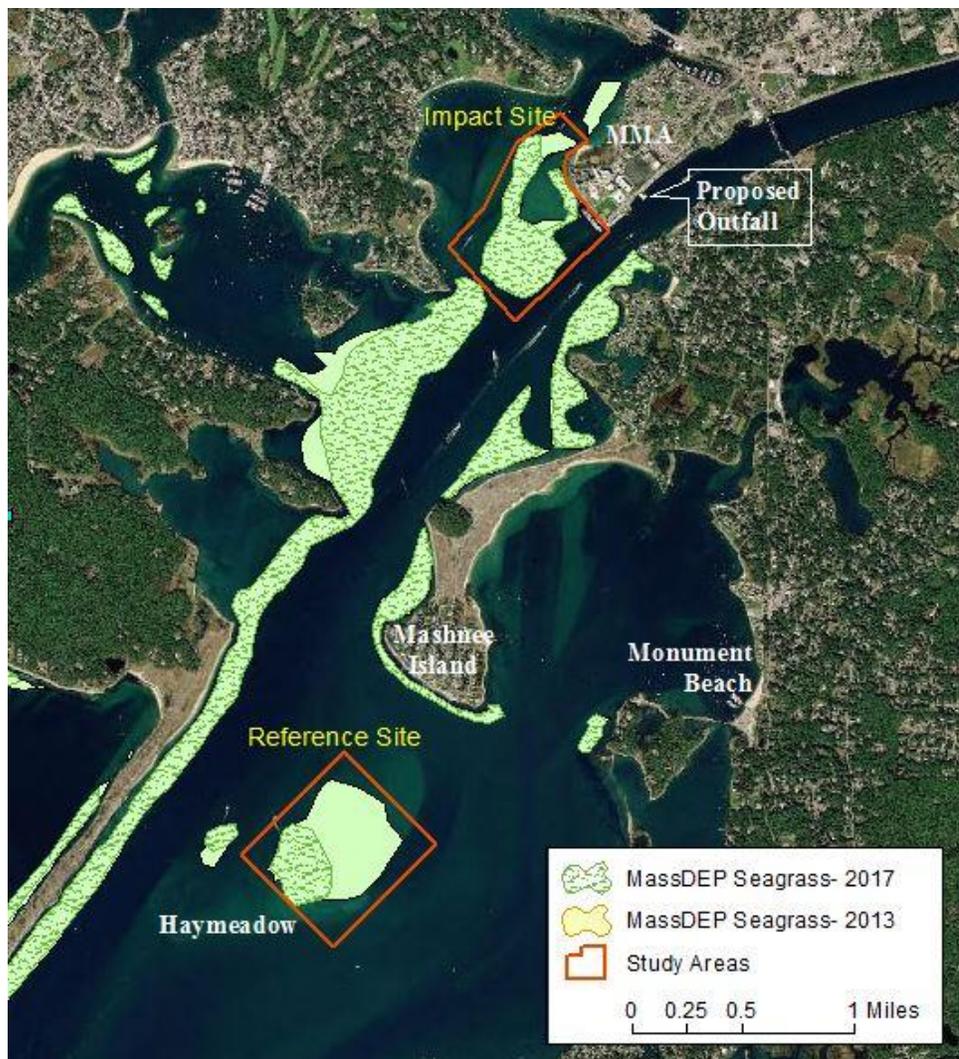
Figure 1. Eelgrass study locations.

1995, 2001, 2006, 2013, and 2017. The Massachusetts Maritime Academy (MMA) impact site is located at the southwestern entrance to the Cape Cod Canal (Figure 1). A preliminary side scan survey with groundtruthing was conducted at the impact site on September 24, 2018 to confirm the size and health of the meadow and determine the final study area boundary.

A reference eelgrass meadow was located across the channel and south of Mashnee Island in an area known as Haymeadow (Figure 1). This eelgrass meadow has a similar size and water depth as the MMA impact meadow and is relatively close to the impact site but far enough away that we do not expect it to be impacted by the new wastewater outfall location. Both sites have the same semi-diurnal tide range 6.85 ft or 2.09 m, have sand-dominated sediment, have a depth range of approximately 1 to 5 meters, and both sites have an average depth of 2.5 meters. Using the results of the preliminary 2018 survey, the eelgrass mapping from DEP, and basemap world imagery data from ArcGIS dated September 29, 2018, final survey areas were delineated in ArcGIS 10.7.

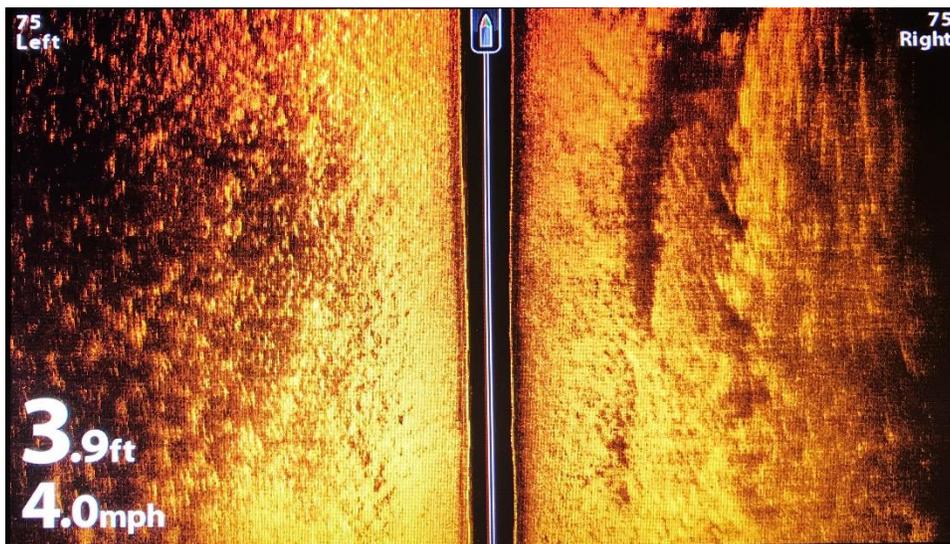
Figure 2. Eelgrass is clearly visible in this side scan sonar imagery as the “puffy” texture.

Side scan sonar is an efficient way to survey eelgrass when aerial photography is not available or the water is too deep or turbid for aerial optical imagery to see the eelgrass. The presence of eelgrass is very clear in acoustic imagery due to the air-filled blades of the eelgrass plant. It can be seen clearly in both side scan imagery (Figure 2) and by the downward looking acoustic depth sensors. At the MMA and Haymeadow study sites, eelgrass grows as a monoculture, which was confirmed with groundtruthing. There is some algae, but it is limited and is not visible in the acoustic imagery at these sites.

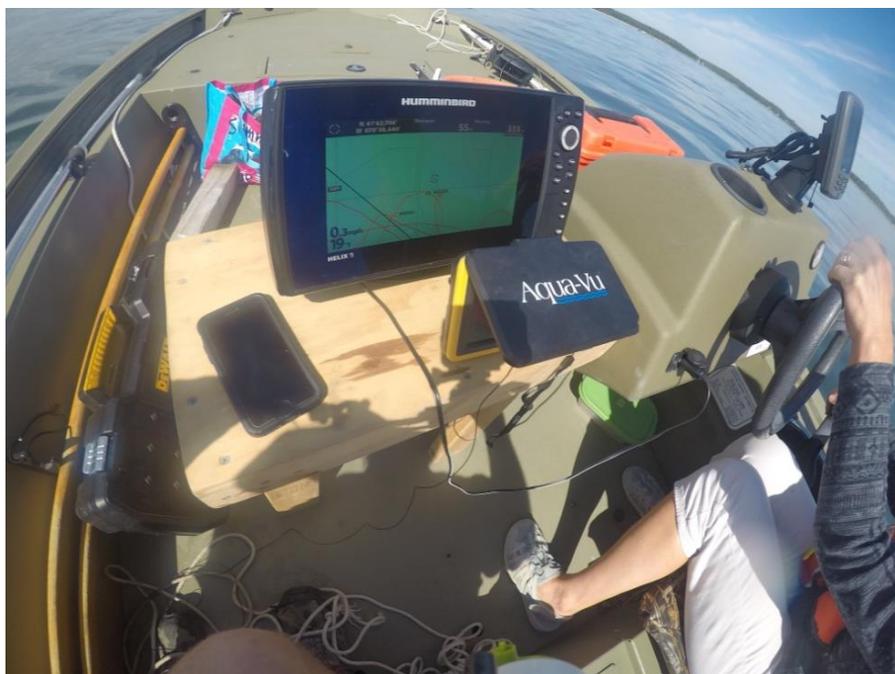
Figure 3. Humminbird Helix9 side scan sonar onboard the R/V Flatfish

The Humminbird Helix9 which supports the sonar frequencies of 50/83/200/455/800 kHz includes down imaging, dual beam, and side imaging. For these surveys we used 800 kHz for the side imaging. The Humminbird transducer was pole mounted on the starboard side gunwale of the R/V Flatfish using a trolling motor mount (Figure 3). GPS is incorporated into the Humminbird system in the display unit. Data was recorded to an SD card in DAT format using the Humminbird data display unit. Due to the shallow and well-mixed nature of the study areas, no sound velocity corrections were needed.

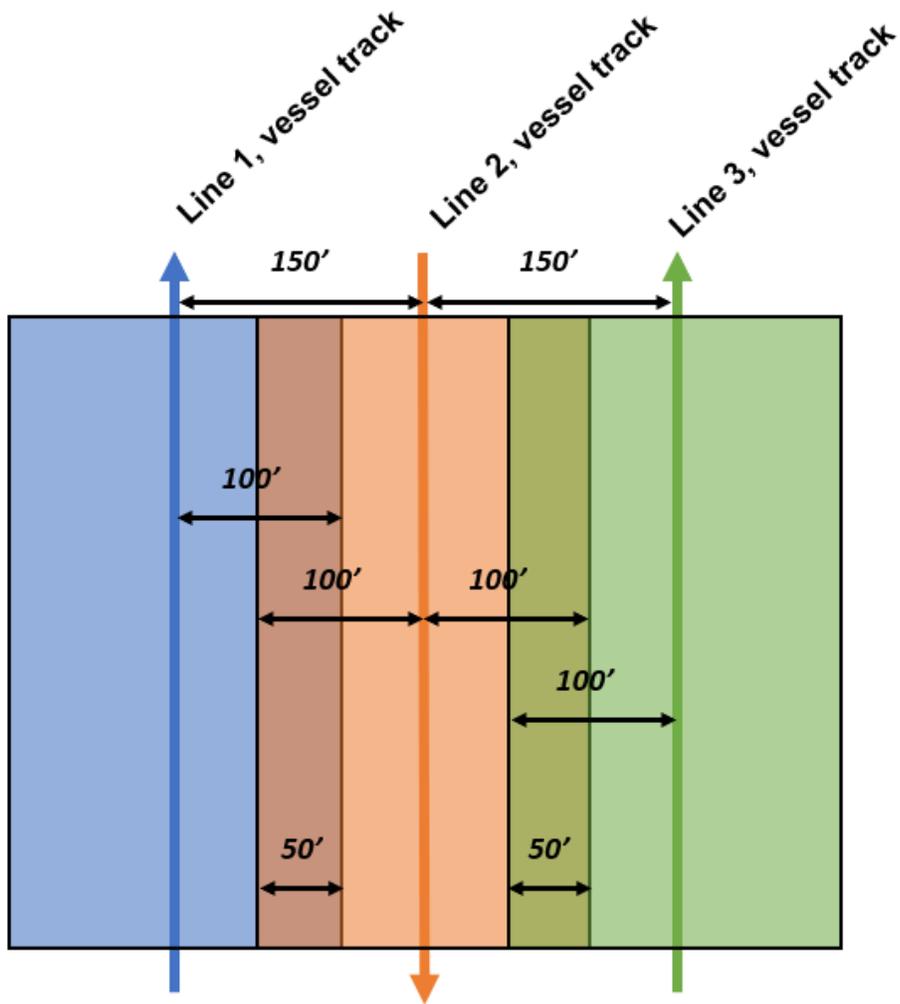
Figure 4. Schematic of overlap. For Line 2, 100' of the original 200' of seafloor imaged is also imaged on Line 1 and Line 3 passes. The overlap is the darker shaded sections of the diagram.

Survey transect lines were positioned 150 feet apart. This was to ensure 150% spatial coverage of the seafloor (Figure 4). This is the operating standard used to improve interpretation of side scan sonar since imagery at the outer edge of the range is often compromised due signal attenuation (Kaeser and Litts 2013). The planned survey lines were oriented to optimize the best direction for data collection based on typical wind conditions (Figure 5).

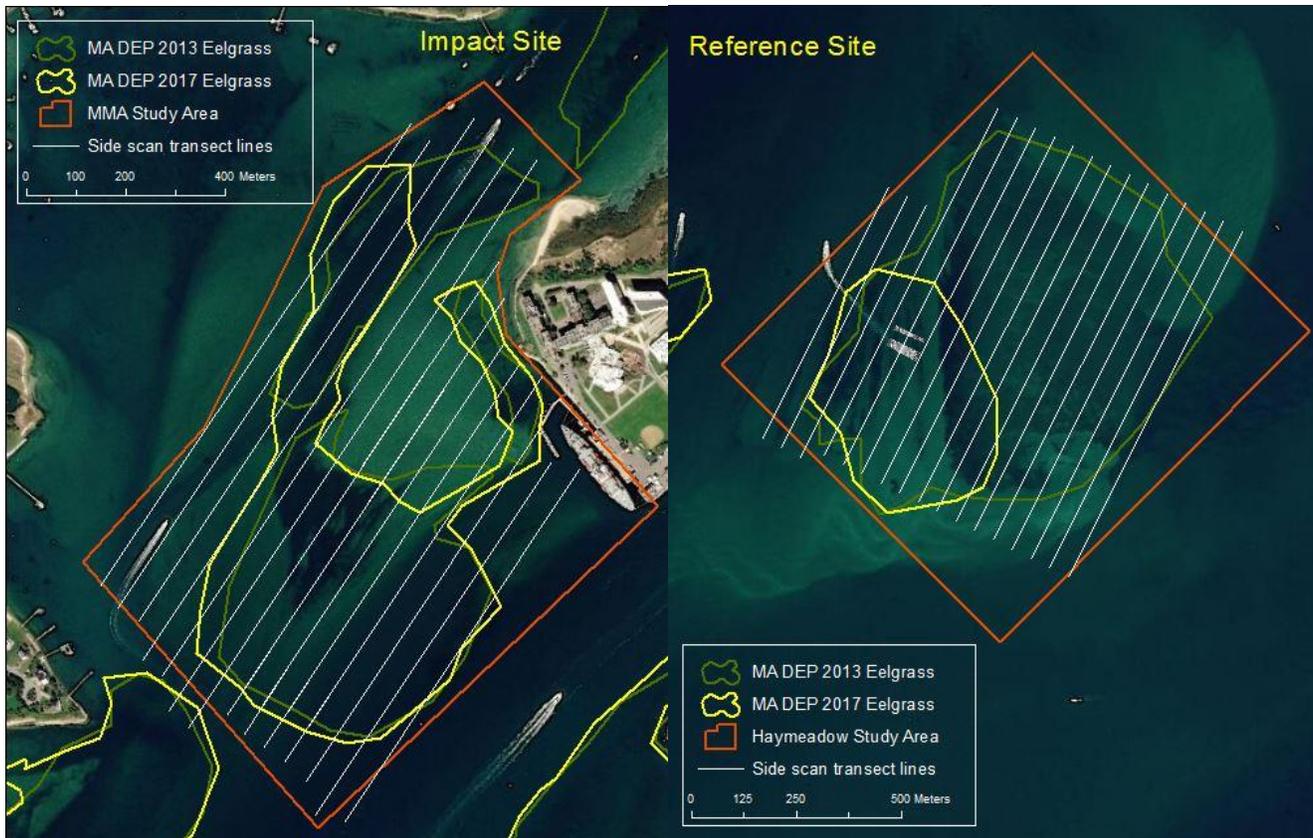
Figure 5. Planned transect lines at the MMA impact and Haymeadow reference eelgrass meadow sites on Sept 2019 aerial imagery basemap.

We found that the area that was surveyed in the originally designated study area box did not fully encompass the northern extent of the meadow so we extended the survey lines to cover that portion of the meadow. Delineating the boundary for this meadow was difficult due to a complicated edge pattern and large bare patches within the meadow making some boundary decisions challenging. The aerial photo does not portray as much eelgrass as was evident in the side scan sonar and the eelgrass boundary we delineated is similar to the DEP delineation from 2013 and larger than the DEP delineation in 2017 (Figure 5).

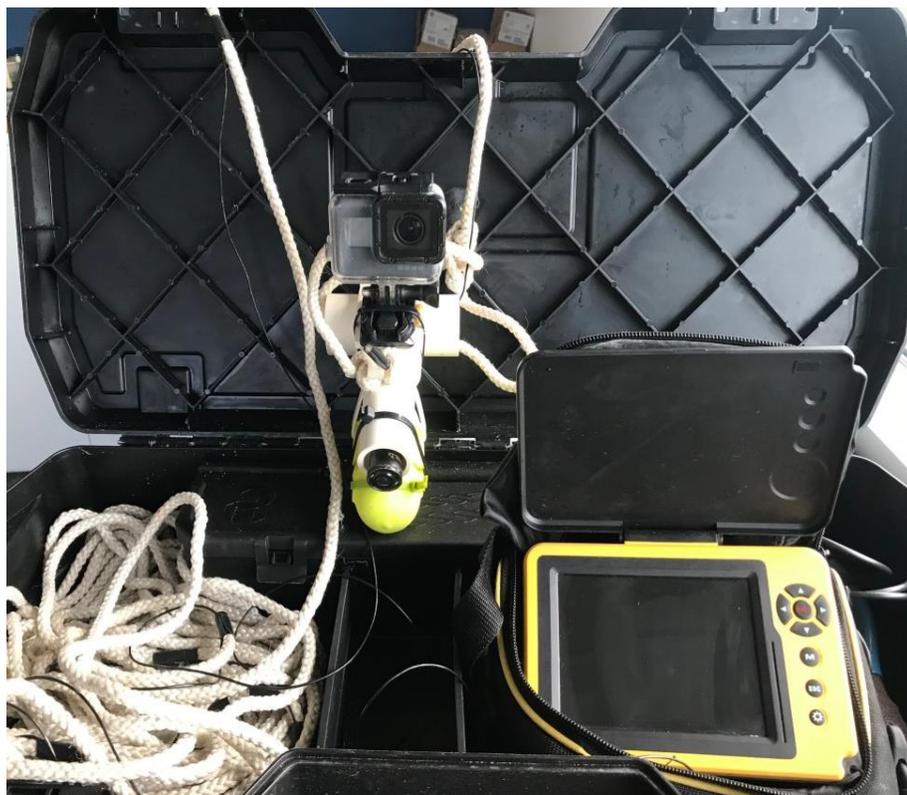
Figure 6. GoPro & Aqua-Vu camera system mounted on weight. The Aqua-Vu camera includes the screen seen in the image. The AquaVu has a live feed to the surface so we can verify that the camera made it to the bottom and we can assign a preliminary seafloor interpretation.

In-water groundtruthing at each selected site was done with an underwater drop camera that included an Aqua-Vu Micro 5 1-MP resolution camera and a GoPro Hero 5 camera with 12-MP resolution in an underwater housing (Figure 6). Both cameras were affixed to a diver weight and lowered from the R/V Flatfish with a rope.

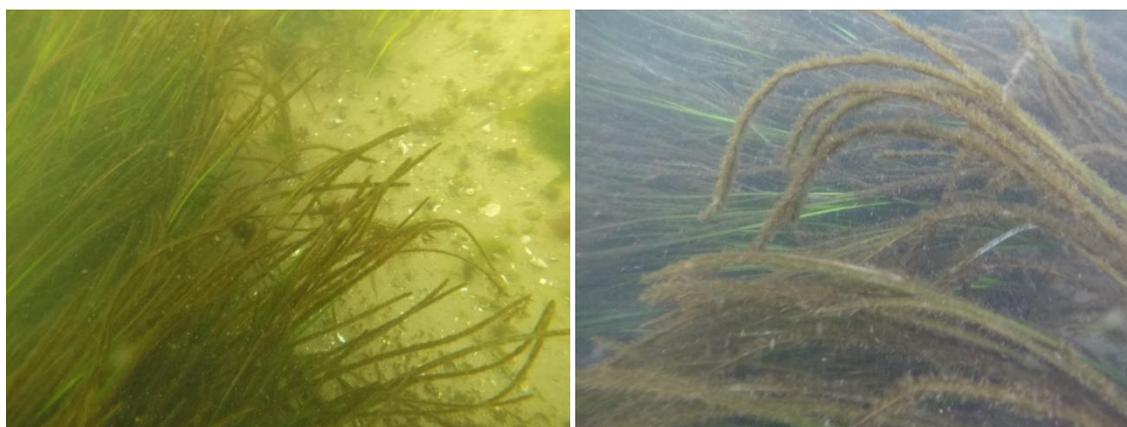
Figure 7. Sample groundtruthing images.

The Aqua-Vu camera was connected to a monitor at the surface and was used as a live video stream to confirm altitude off the bottom and water clarity. The GoPro was set to capture high definition still images at a 2 second interval. When water clarity allowed, groundtruthing was done by looking over the side of the boat. This system is set up to give information about the presence or absence of eelgrass (Figure 7).

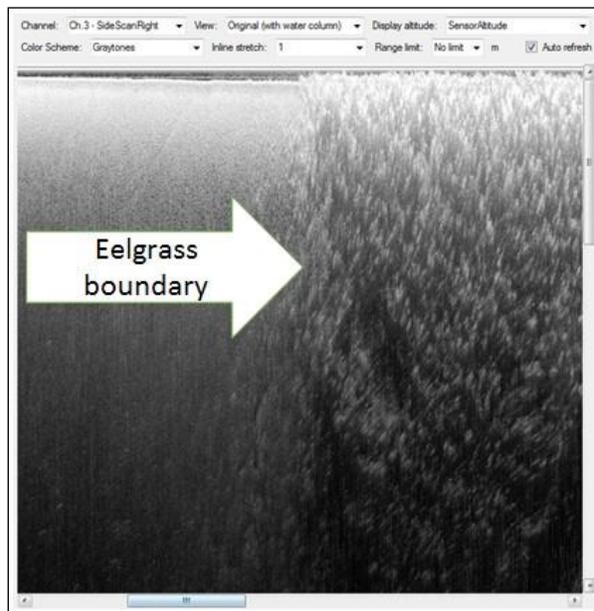
Figure 8. Humminbird data in playback view in SonarTRX showing eelgrass boundary.

The side scan sonar data from the Humminbird Helix9 was processed with SonarTRX Pro Ver. 15.1.5859.19587. SonarTRX is a software system that can view and process both 2D and 3D hydroacoustic data from multiple low- and high-end side scan sonar units. The primary processing steps included beam angle, slant range, and removal of the water column corrections. The corrections place each sonar ping in the correct geographic space on the seafloor. The processing workflow followed DMF standard operating procedures for SonarTRX processing. Positional error is related to several variables such as survey speed, GPS signal quality, and variation in vessel and transducer heading relative to course made good. The extent of this error has not been tested at this time but based on in-field experience we estimate it to be approximately 10 feet.

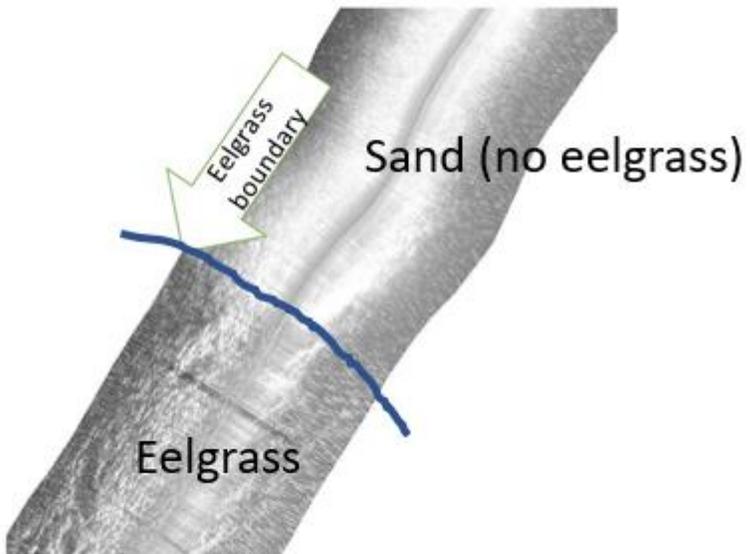
Figure 9. Humminbird data as a geo-referenced mosaic in ArcGIS showing eelgrass boundary

Each georeferenced transect line was exported for viewing in ArcGIS 10.7 as GeoTIFFs. The assemblage of transect lines in the GIS software were used to create a mosaic of the whole study area and delineate the boundary of the eelgrass meadows (Figure 9). Habitat delineation was done in ArcGIS 10.7 at a range of scales from 1:500 to 1:2,000.

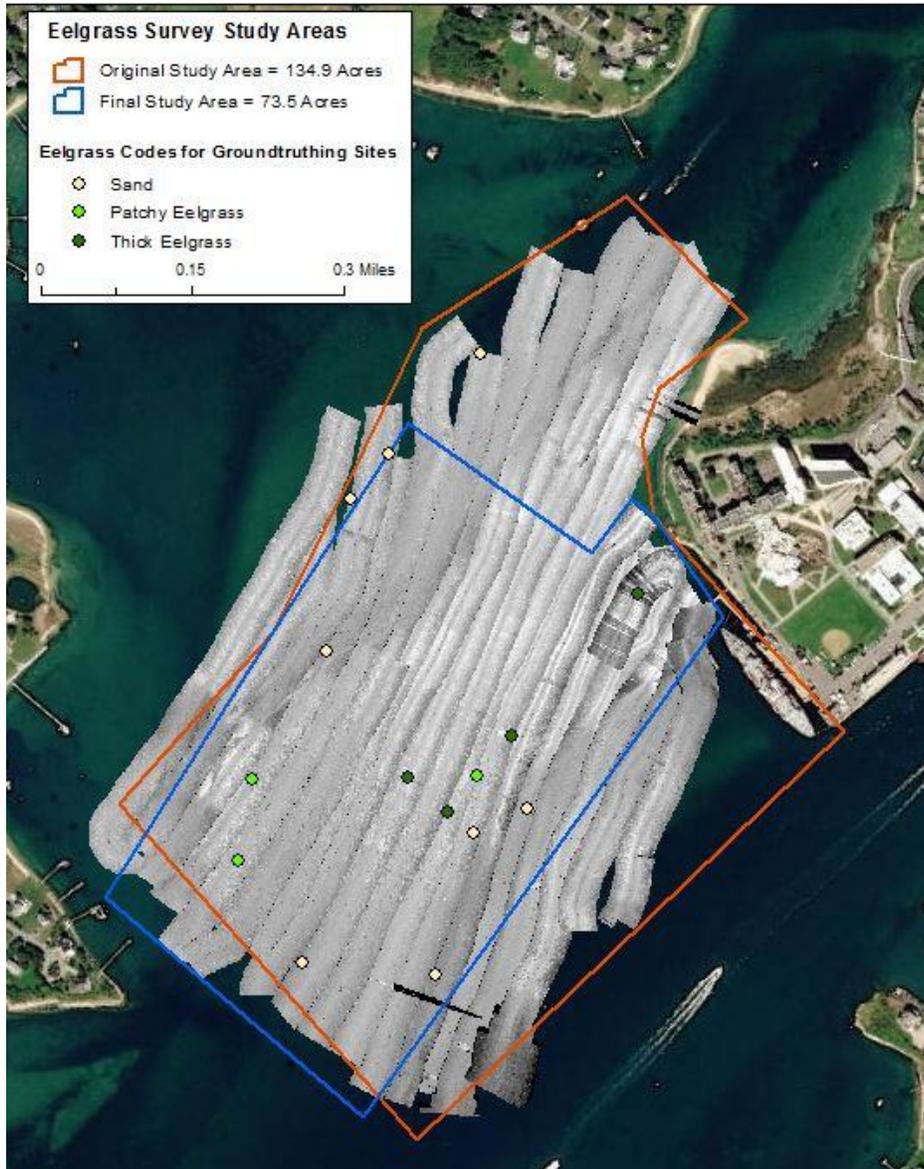
Figure 10. Side scan sonar mosaic and groundtruth points from pilot study in 2018 at the MMA impact site.

The 2018 pilot study of the MMA impact site helped us define the boundary for the final impact site survey area. Using the side scan sonar mosaic and groundtruth points, we reduced the original planned survey area by approximately 61.4 acres (Figure 10). We also confirmed some logistical details including that the site was a suitable area for surveying in a single day and that a second day would be needed to survey the reference site due to the distance from the impact site. Both sites were confirmed to have accessible boat ramps to enable safe and efficient access to the sites.

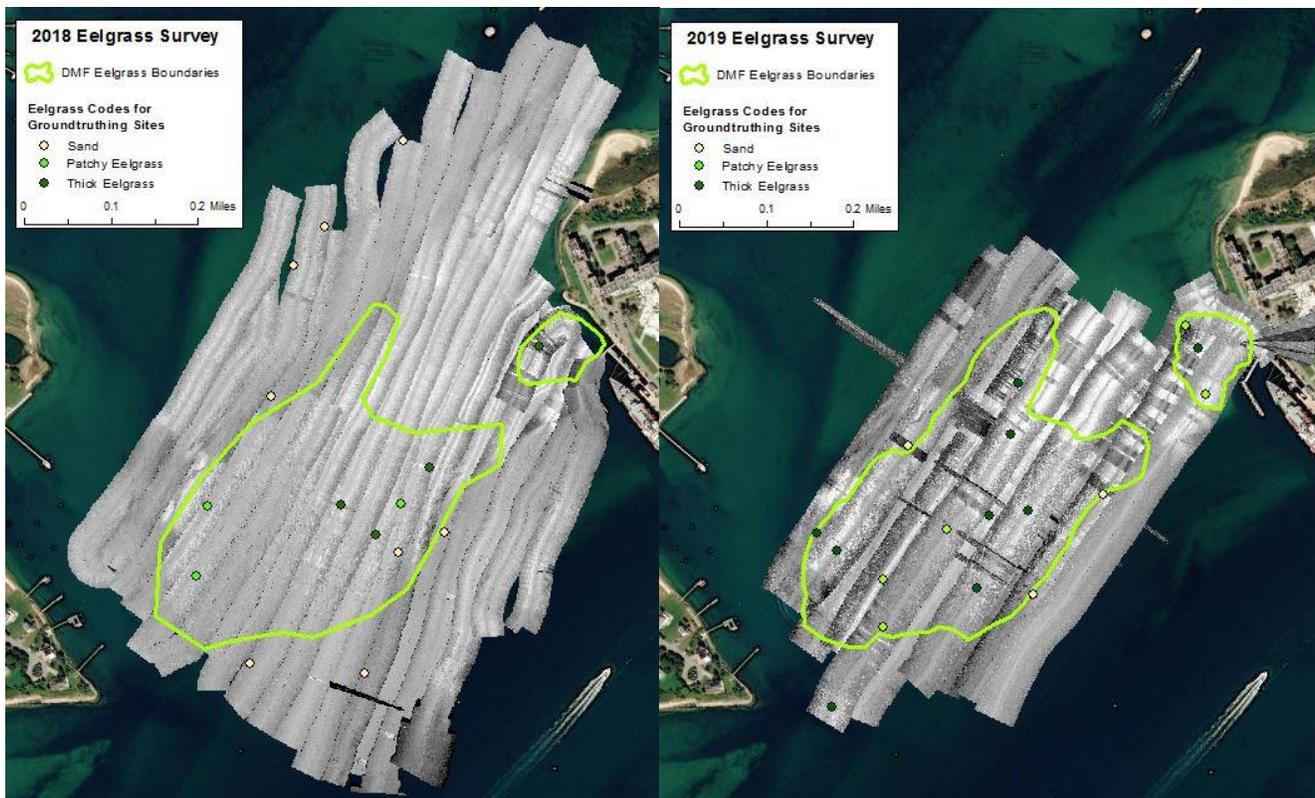
Figure 11. Eelgrass delineation in 2018 and 2019 at the MMA impact site.

The eelgrass boundaries at the MMA impact site are shown in Figure 11. The area of eelgrass was 55.1 acres in 2018 and 54.4 acres in 2019.

The acreage of the eelgrass meadow at the MMA impact site was 0.7 acres less in 2019 than in 2018. The overall size, shape and acreage of the eelgrass meadow suggests that little change occurred and that the difference is due to error associated with boundary delineation. Comparing the aerial imagery with the side scan imagery confirms that the side scan sonar imagery had good geographic positioning since eelgrass meadow edges measured in each method were comparable. Our delineations are broadly comparable to the DEP delineations in 2013 and 2017, suggesting limited change in the overall areal extent of this eelgrass meadow between 2013 and 2019. The main difference is that DEP has the meadow extending to the north into the river channel. Based on our pilot work, we do not think that eelgrass is growing into the river channel. If it does, then there is a considerable gap of hundreds of feet between a potential river channel eelgrass meadow and the main meadow that is the primary focus of this investigation.

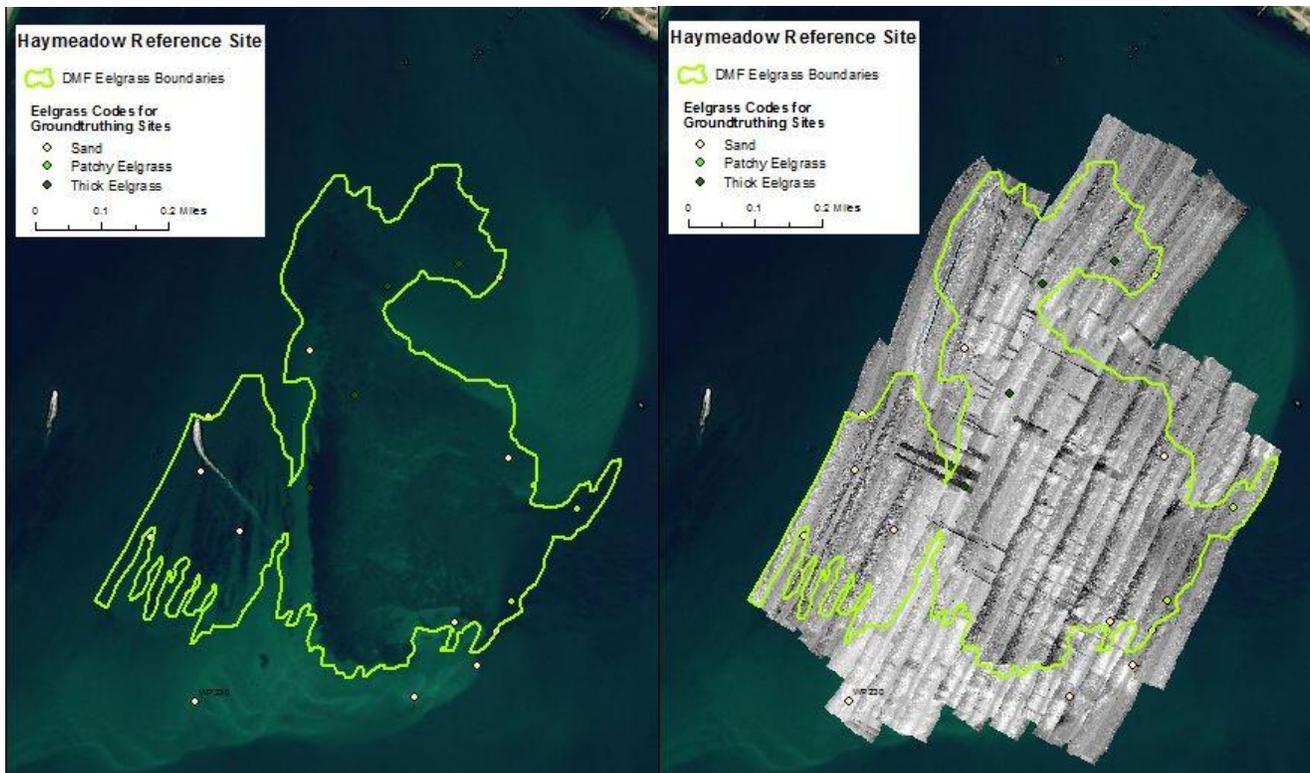
Figure 12. Aerial imagery from Sept 2018 (left) and the sonar mosaic with groundtruthing points from Aug 2019 (right). The eelgrass delineation done with the 2019 side scan sonar data is overlaid on both images as a green line.

The eelgrass boundary at the Haymeadow reference site is shown in Figure 12. The area of eelgrass was 96.9 acres in 2019.

At the Haymeadow reference site, delineating the boundary of the eelgrass was challenging due to the patchiness of the meadow edges. Therefore, comparisons year over year of the specific boundary may be more approximate. Our delineation was more similar to the DEP delineation from 2013 than 2017. We also found more eelgrass to the north of the meadow than DEP delineated in either year. The northern eelgrass is hard to see in aerial images since it is in deeper water. In order to confirm if the differences with the DEP delineations were due to changes in the meadow or are a result of imagery quality or scale differences needs to be assessed.
