**ARCH CANYON CONDITION ASSESSMENT
AND MANAGEMENT RECOMMENDATIONS**

**Report for the
Southern Utah Wilderness Association**

ECOS Consulting

August, 2006

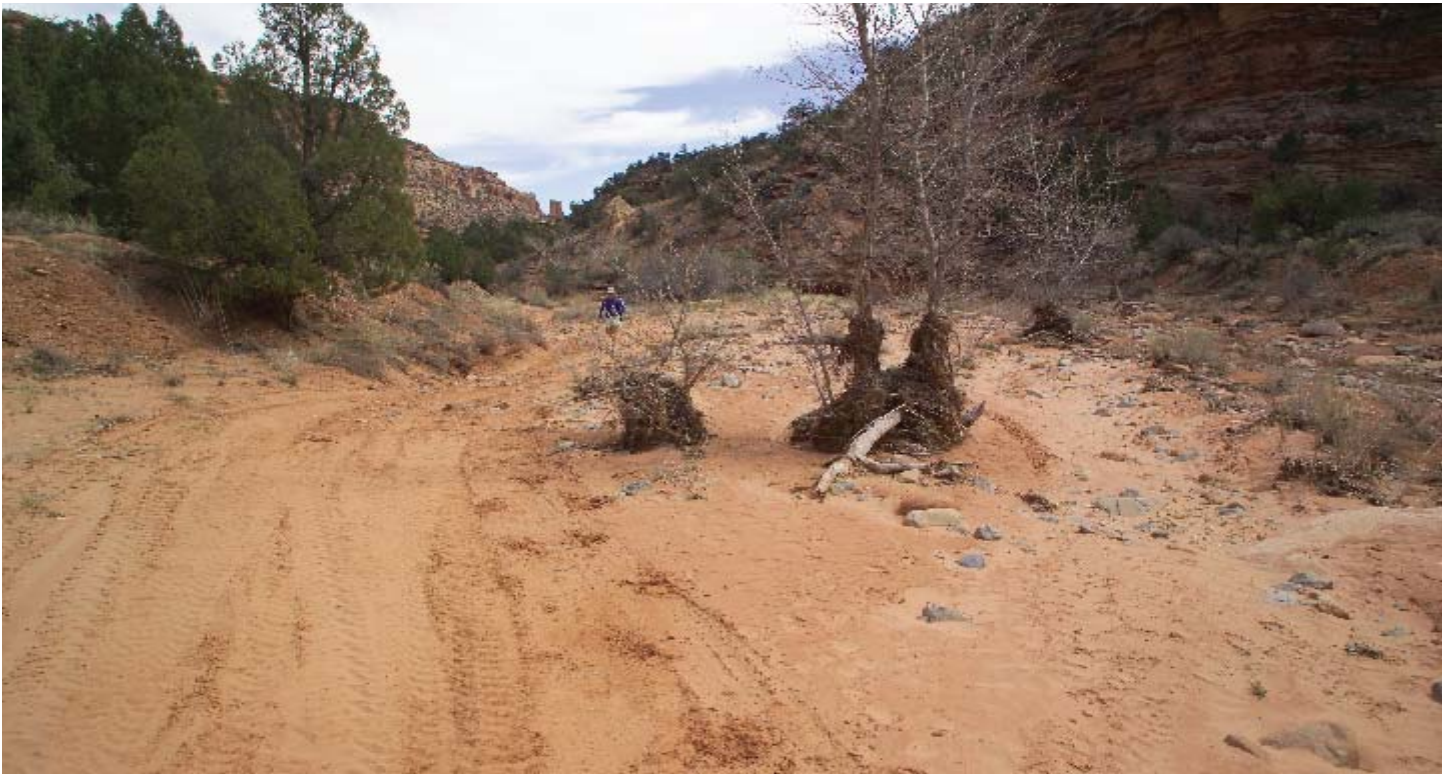
The channel condition in Arch Canyon varies throughout the area investigated. There is consistent evidence of past degradation, present channelization, and, in particular, channel straightening and widening caused by lateral cutting and the loss of vegetation. There are areas where the stream flow has connected with the 4-wheel drive route and straightened. This resulted in bank failure and lateral cutting, destroying riparian vegetation and the stream bank. This condition is evident at numerous sections in Arch Canyon. It is indicative of a stream channel that has lost its stability and energy absorbing capacity to slow and spread the water out onto the floodplain, an extremely valuable ecological function. See **Figure 3** below for a typical example of this.

FIGURE 3. Downstream view where high water widened the channel and eliminated the riparian vegetation, streambank, and floodplain between the stream on the right and the 4-wheel drive route on the left. Arch Canyon, San Juan County, Utah.

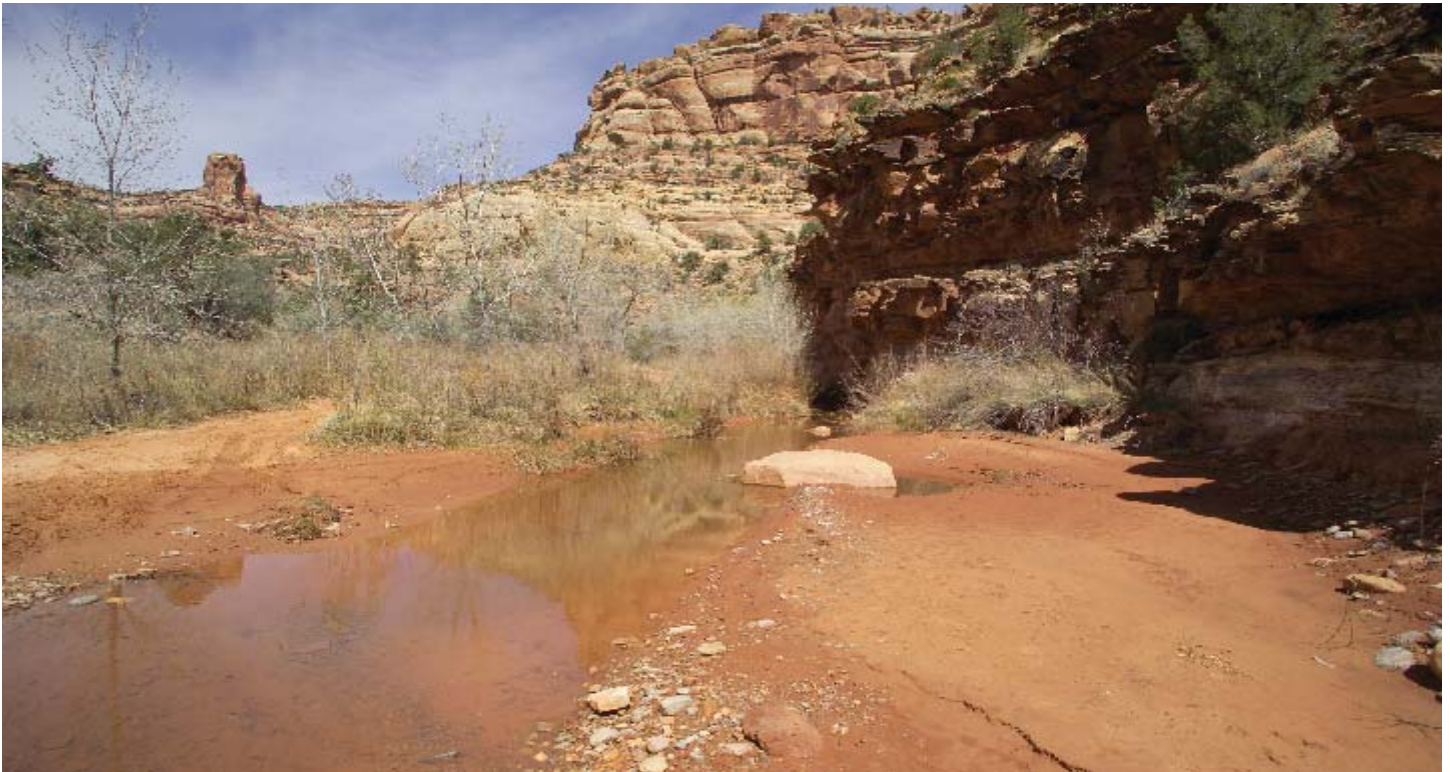
FIGURE 4. Upstream view at place where 4-wheel drive route crosses the channel. Channel upstream of route is in Functional condition. See Figure 6 for downstream view. Arch Canyon, San Juan County, Utah.

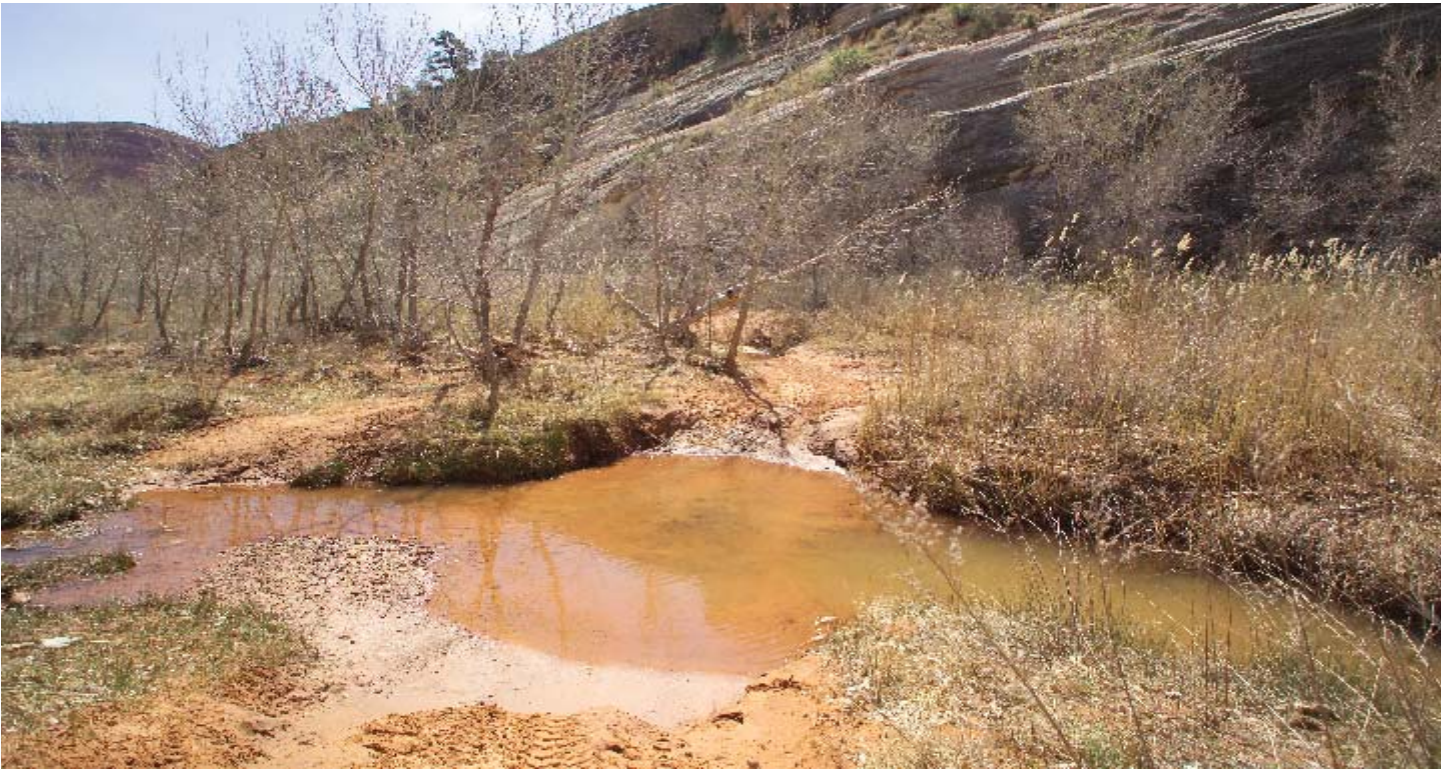
FIGURE 5. Pool formed by the 4-wheel drive route crossing the creek in Arch Canyon, San Juan County, Utah. Deep pools initiate wider route scars and additional crossings and destabilize banks. Flannelmouth suckers were found just upstream.

Figures 5, 6, and 8 show excellent examples of streambed rock armoring in Arch Canyon. Without this important riparian element, the channel in Arch Canyon would be in much worse shape. Too much rock armoring, especially along the banks, has a disadvantage in that it inhibits vegetation establishment, extensive root development, and point bar development. Although there are exceptions, most sections of Arch Canyon contain cobbles over 2.5 inches in diameter in at least 40% of the streambank. The most notable exception is where the 4-wheel drive route crosses the stream. At these crossings, rocks are broken up and displaced, creating an almost entirely smooth sandy streambed and bank (see **Figure 11**) at and downstream of the crossing. These sandy areas enlarge and soon spread downstream as more and more flood events with increased energy scour the pools. Over time the pools deepen by scouring during floods, creating deep open sandy areas that vehicles avoid by driving around them, thus spreading the damage to an ever wider area.

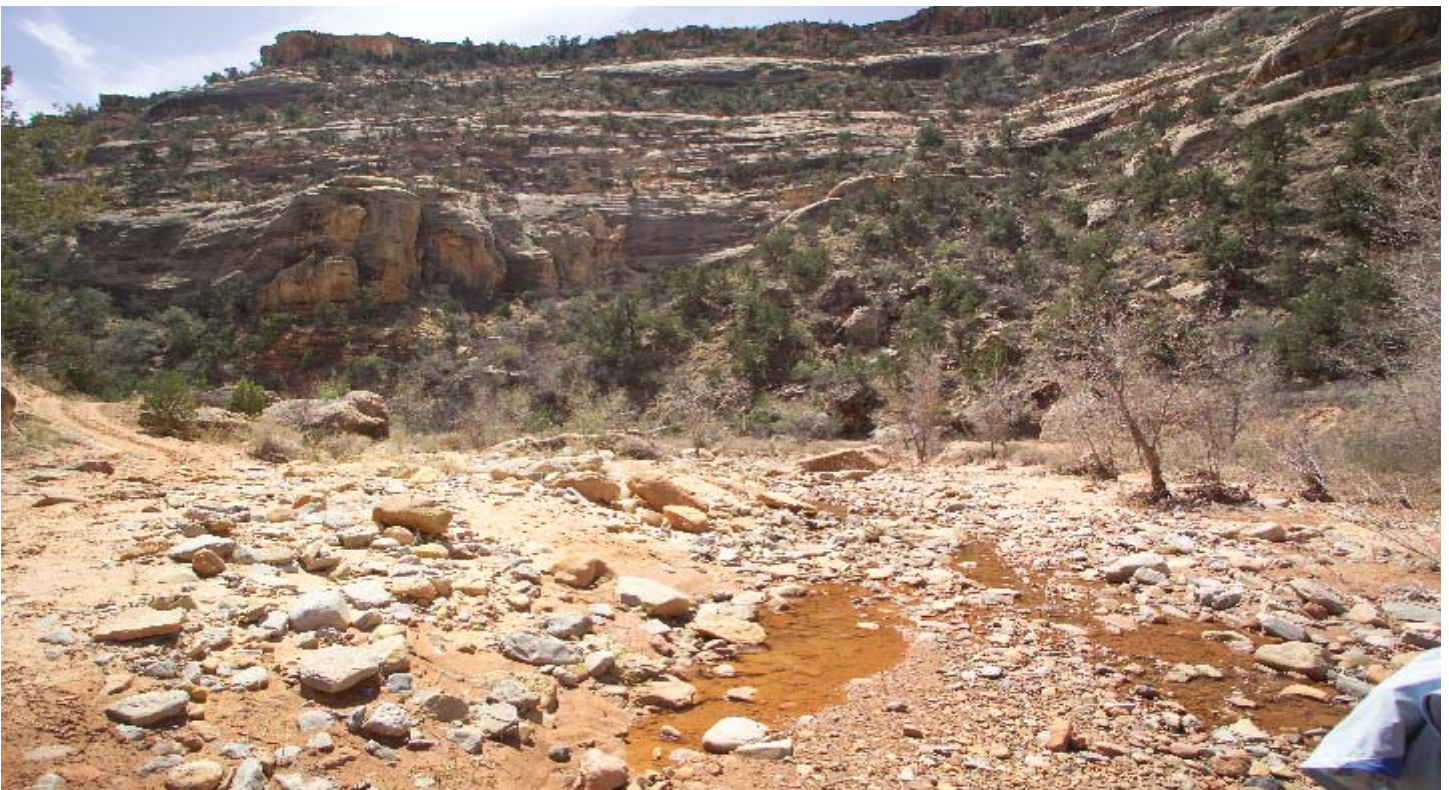
FIGURE 6. Downstream view of Figure 4 where 4-wheel drive route crosses the channel. Channel is in Non-Functional condition due to loss of bank, soil and vegetation. Arch Canyon, San Juan County, Utah.

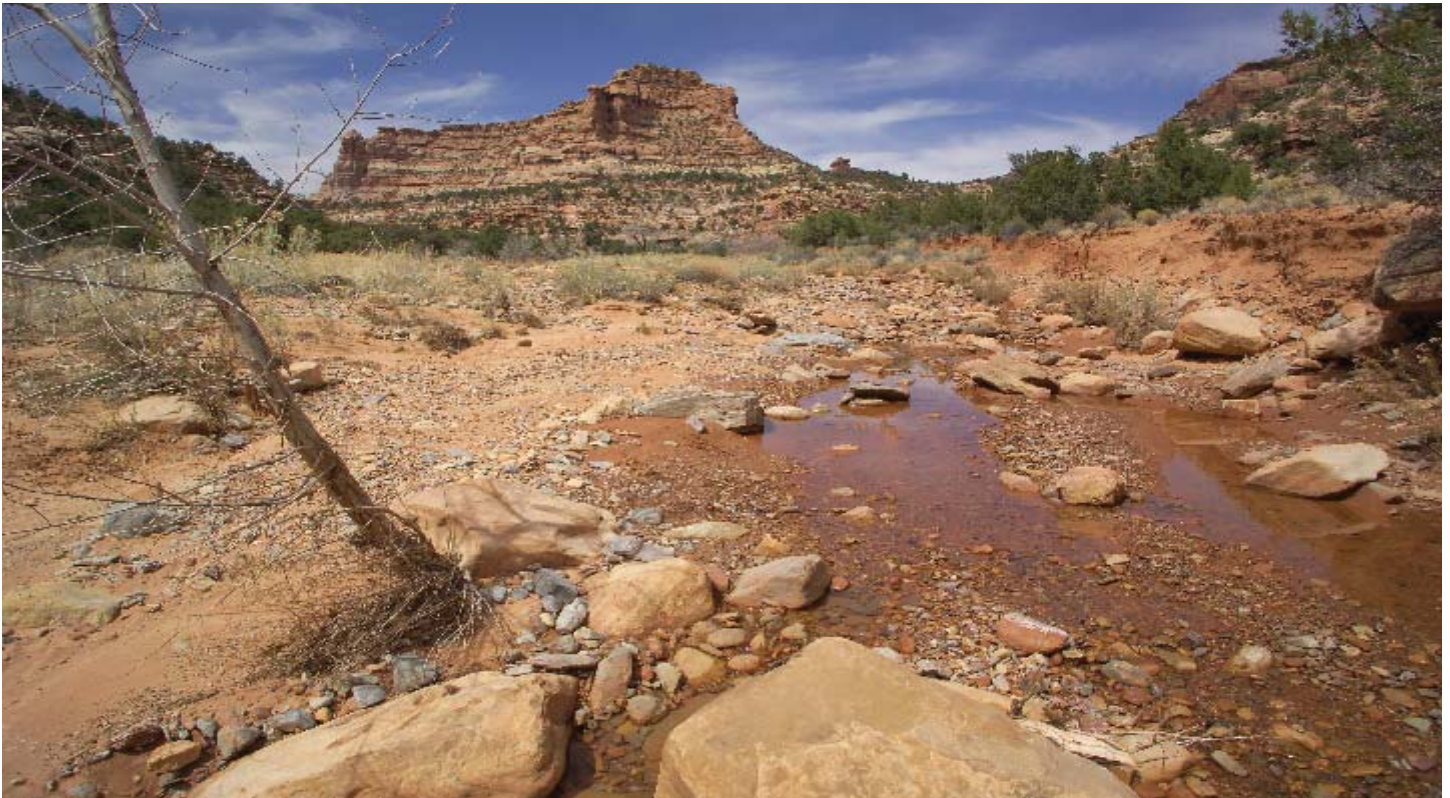
FIGURE 7. Upstream view at section where the 4-wheel drive route eliminated vegetation on the stream bank and caused the bank to degrade significantly. The 4-wheel drive route crossing has subsequently been moved downstream where bank erosion is beginning to re-occur. Arch Canyon, San Juan County, Utah.

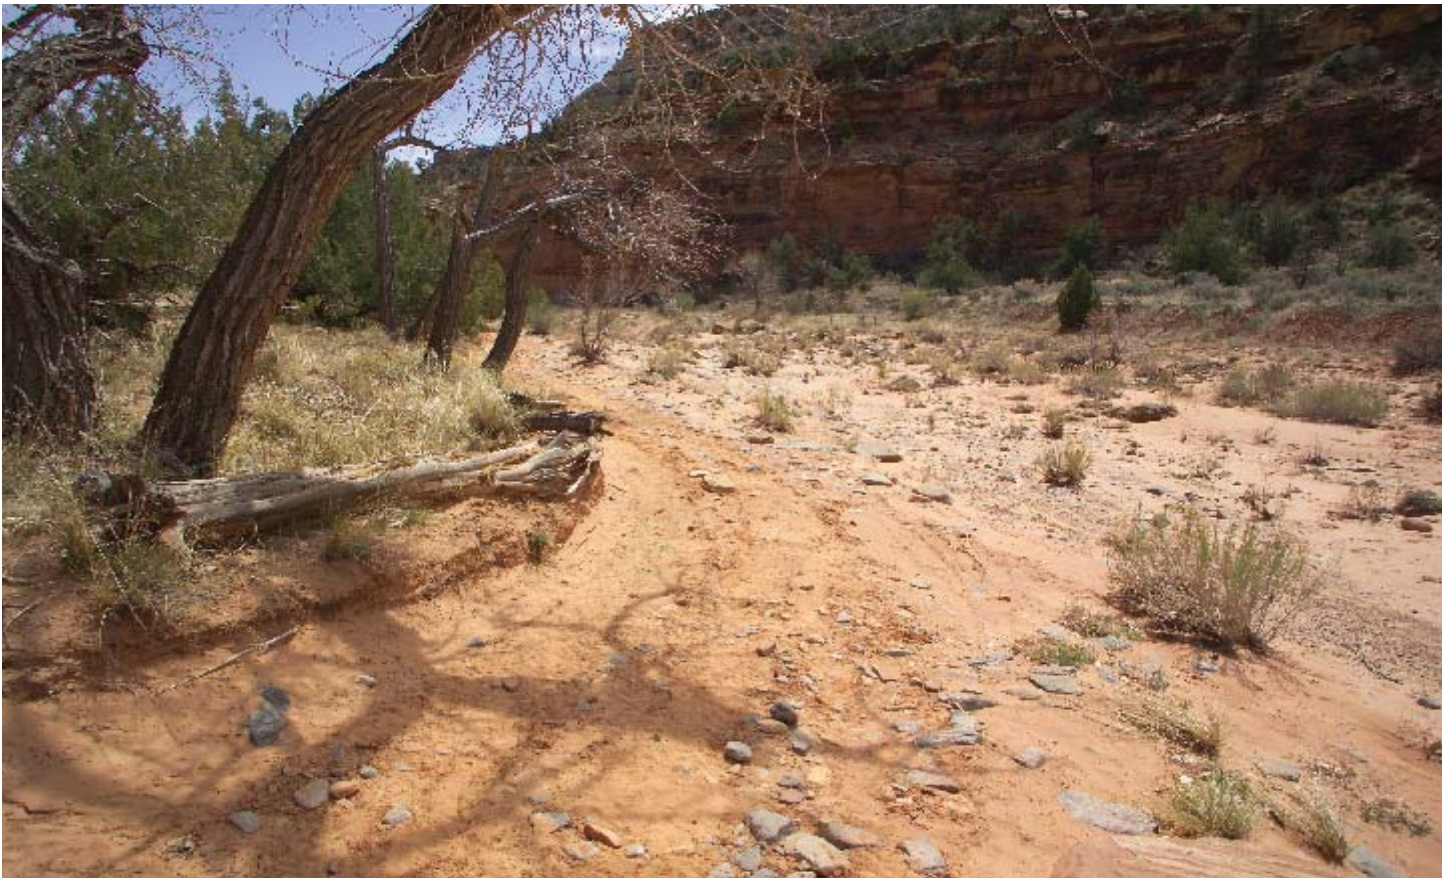
In Arch Canyon, although conditions vary with every flood event, it is estimated that 60% of the “middle” reach has sufficient soil to hold water and act as a rooting medium. In the other 40%, due to frequent high velocity flows and lateral cutting, vegetation establishment and maturation in the floodplain has been impeded.

FIGURE 8. Area where lateral cutting of the bank between the 4-wheel drive route and the channel occurred. This process inhibits vegetation establishment and maturation. Arch Canyon, San Juan County, Utah.

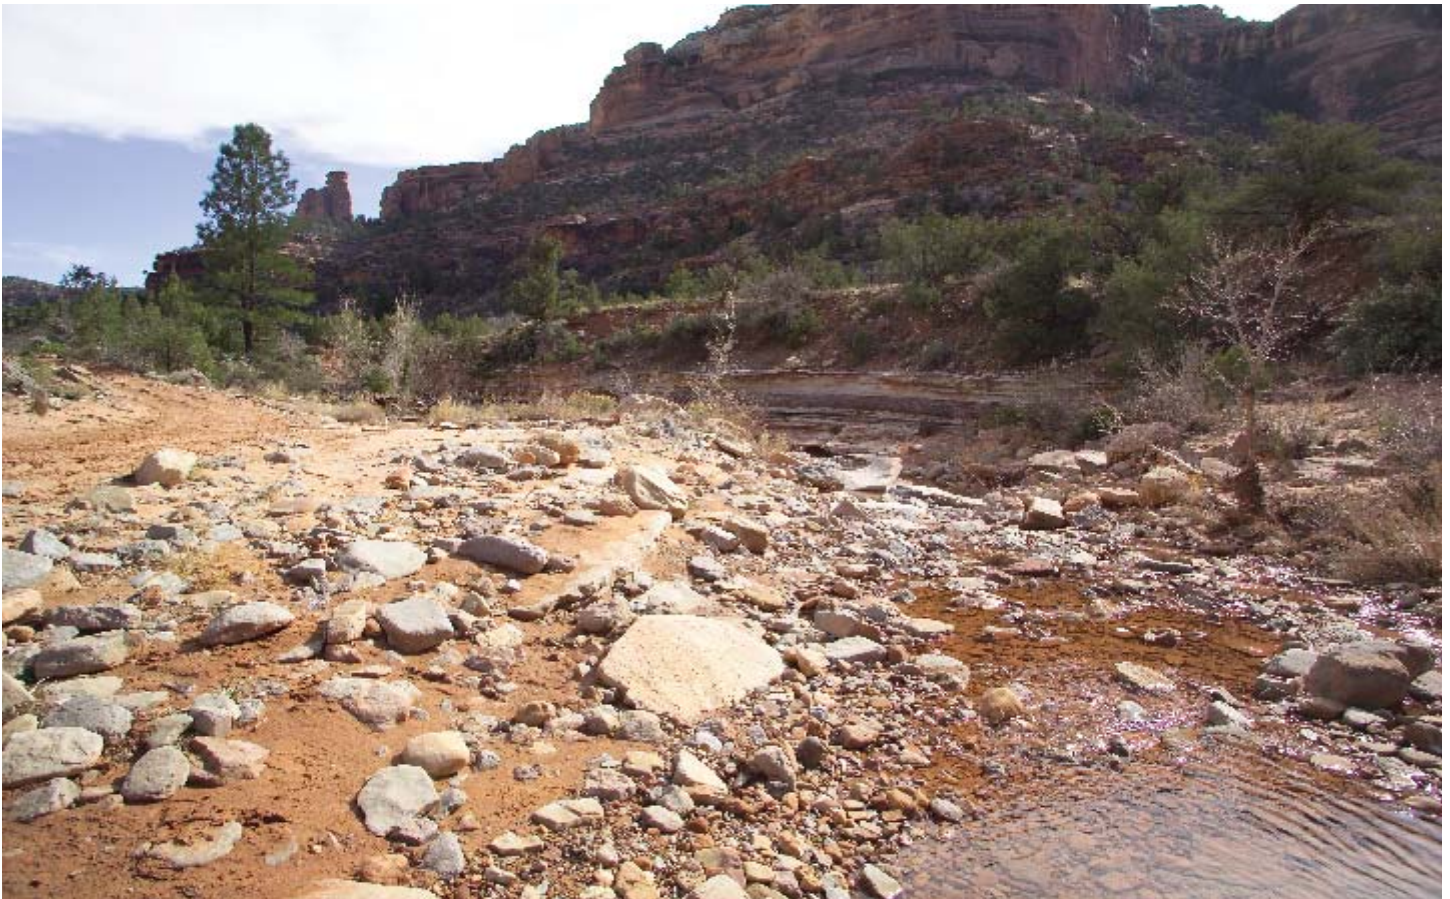
It is estimated that at least 20% of the “middle” reach riparian area has exposed soil surface due to lateral cutting of the streambanks and the consequent loss of vegetation. See **Figure 9** below for one of many examples of exposed soil throughout the “middle” reach of Arch Canyon.

FIGURE 9. Upstream view at section where vegetation on the stream bank has been eliminated, causing the bank to degrade significantly. Arch Canyon, San Juan County, Utah.

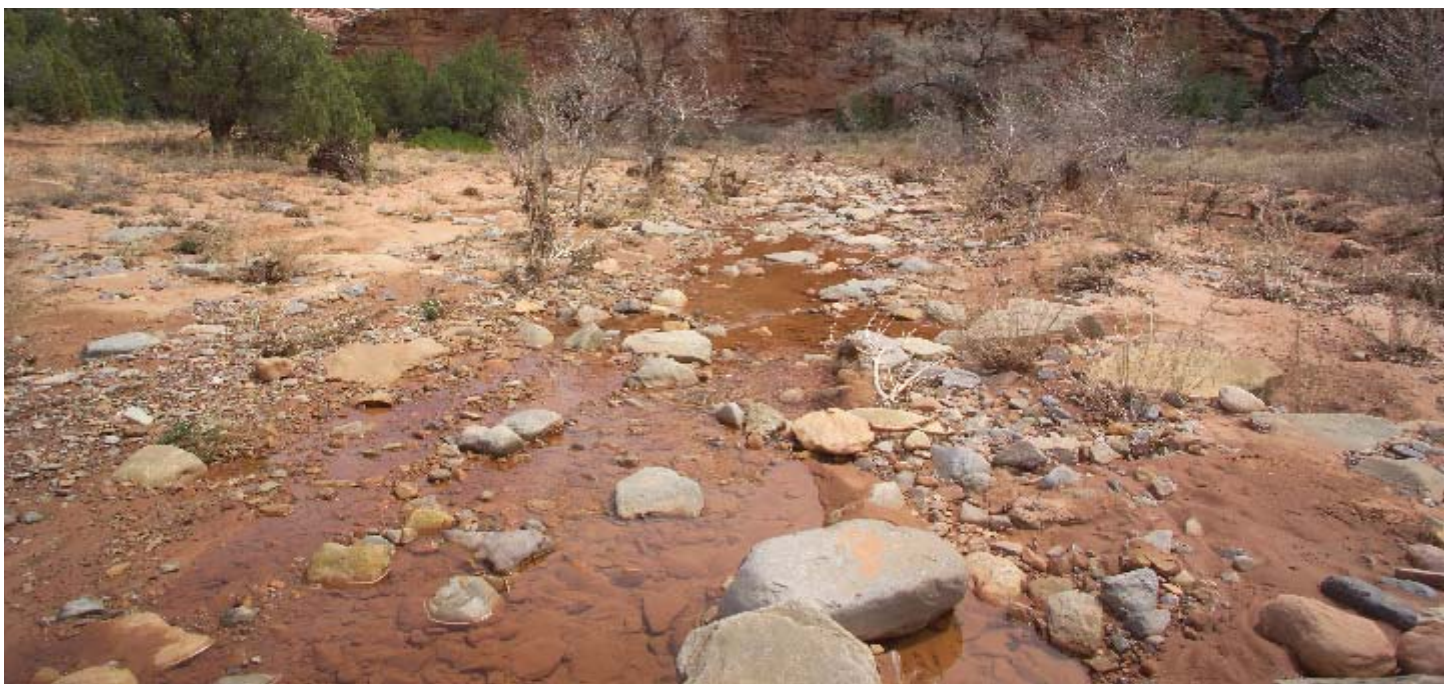
Many sections of Arch Canyon have a high channel width/depth ratio, as well as 4-wheel drive route-initiated secondary channels that prevent access of overflow to the floodplain. These artificial secondary channels widen the channel by encouraging lateral or sideways cutting with the subsequent loss of vegetation and soil. This action decreases flow resistance and increases flow velocity. It thus impedes the settlement of soil and development of a functioning floodplain.

FIGURE 10. View of area where vegetation in the floodplain has been eliminated and caused the bank to degrade significantly. Arch Canyon, San Juan County, Utah.

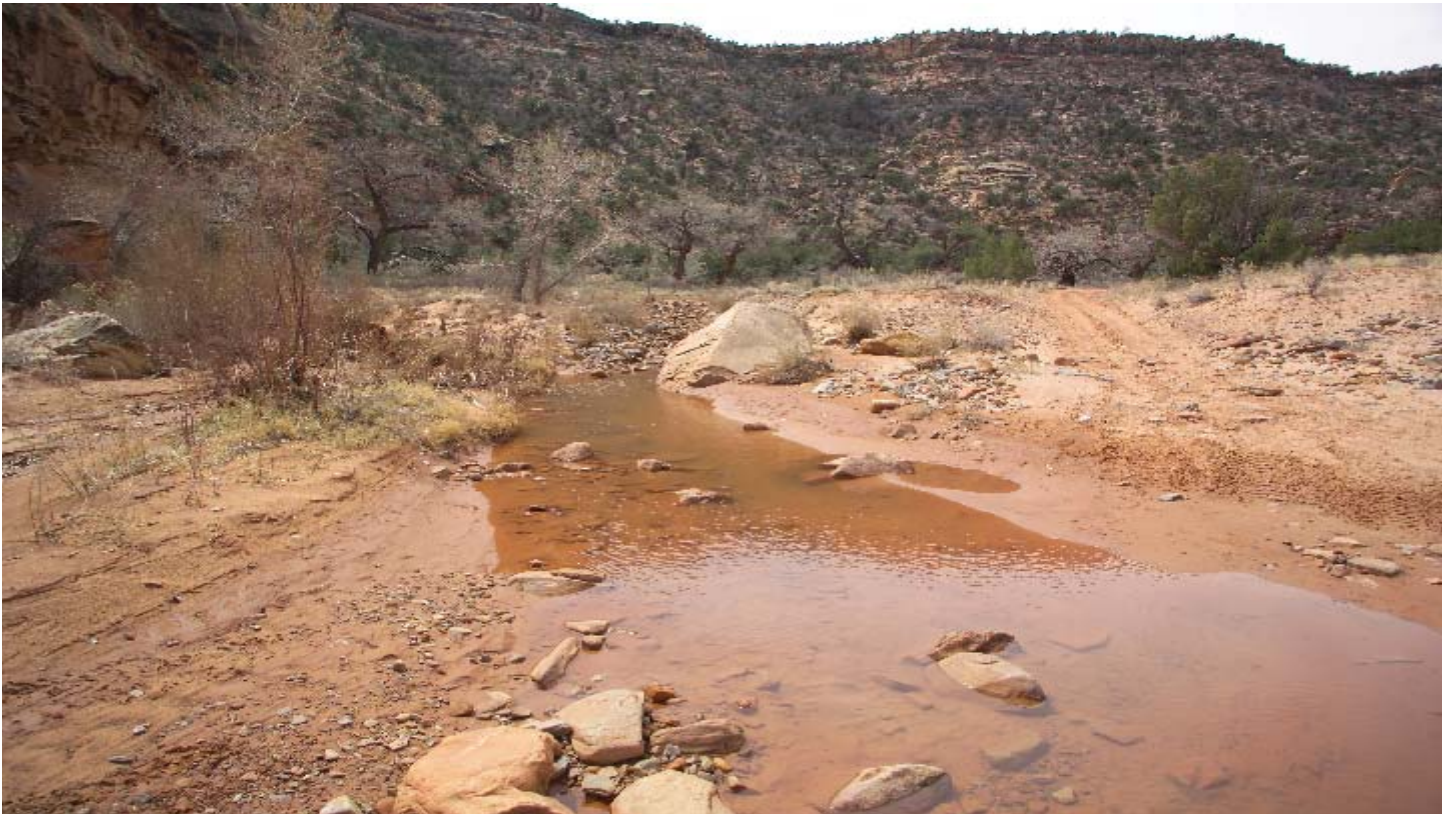
FIGURE 11. Typical 4-wheel drive route crossing where streambank rock armoring has been displaced and a pool is beginning to form. Arch Canyon, San Juan County, Utah

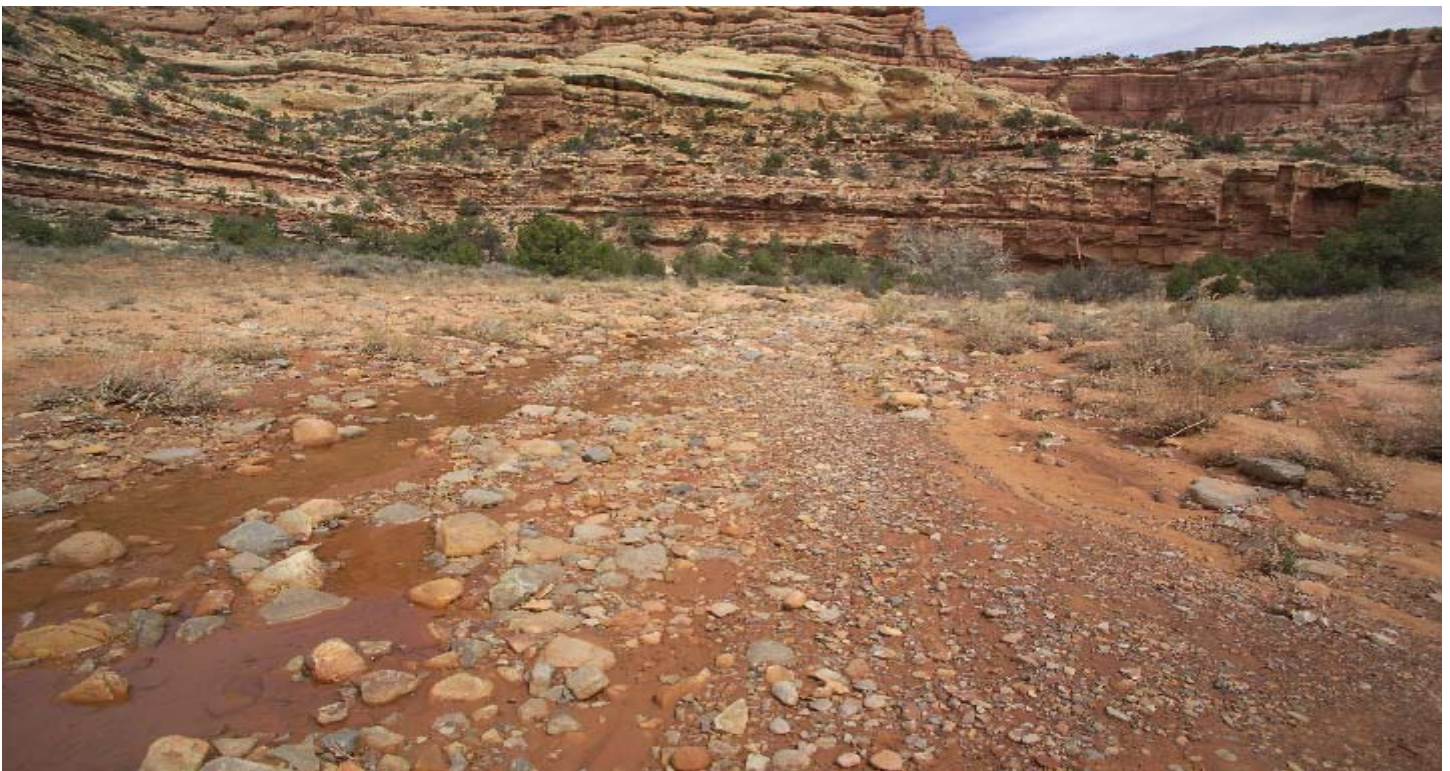
There are many sections in Arch Canyon where the scouring and flow velocity has increased to the extent that sediment does not have a chance to settle and the formation of point bars is inhibited. This widens the channel and prevents a proper functioning condition from developing, especially the extremely valuable functions of increased vegetation development, sedimentation, and sinuosity. Degraded banks are either scoured to bedrock or left with a jumble of large cobbles and boulders (See **Figure 12** below). This rock armoring protects the channel from excessive erosion, but it usually is not enough to encourage the development of a soil base and vegetation. Point bars with a developed vegetation component do occur in sections of Arch Canyon, but there are many areas where point bar development is inhibited, and the channel is widening and tending away from balance.

FIGURE 12. Area where the formation of point-bars has been inhibited due to increased flow velocity. Arch Canyon, San Juan County, Utah.

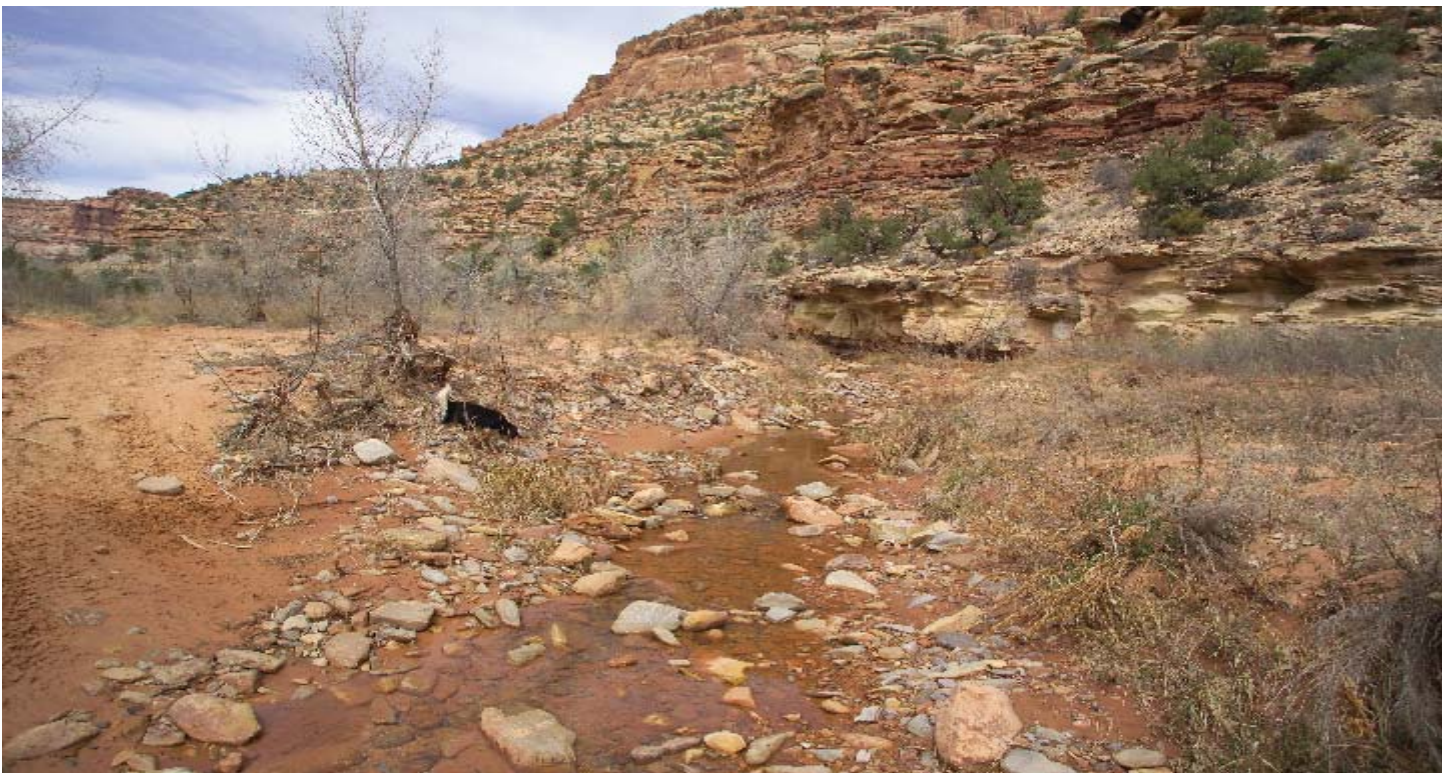
In Arch Canyon, the range of age classes of cottonwood trees includes seedlings, saplings, poles, and old mature trees, with a conspicuous sparsity of young mature trees. It appears that regeneration of the cottonwoods was greatly inhibited by intensive past livestock grazing. Grazing was eliminated from Arch Canyon in the mid-1990’s, with resulting regeneration over the younger age classes in the past 15 years. However, there is a gap in the young mature stage that will take years to correct. **Figure 13** shows a typical area where young mature and mature trees are missing. The trend is positive but there are indications that conditions still exist that inhibit tree development in the stream channel. Due to the apparent increased velocity of the flow during floods, there is much lateral cutting and loss of sediment. This increased energy can destroy established trees and retard development of the younger age classes in the floodplain. Overall however, more than 10% of the canopy cover is represented by seedlings and saplings, indicating a healthy condition.

FIGURE 13. Cottonwood regeneration in Arch Canyon, San Juan County, Utah.

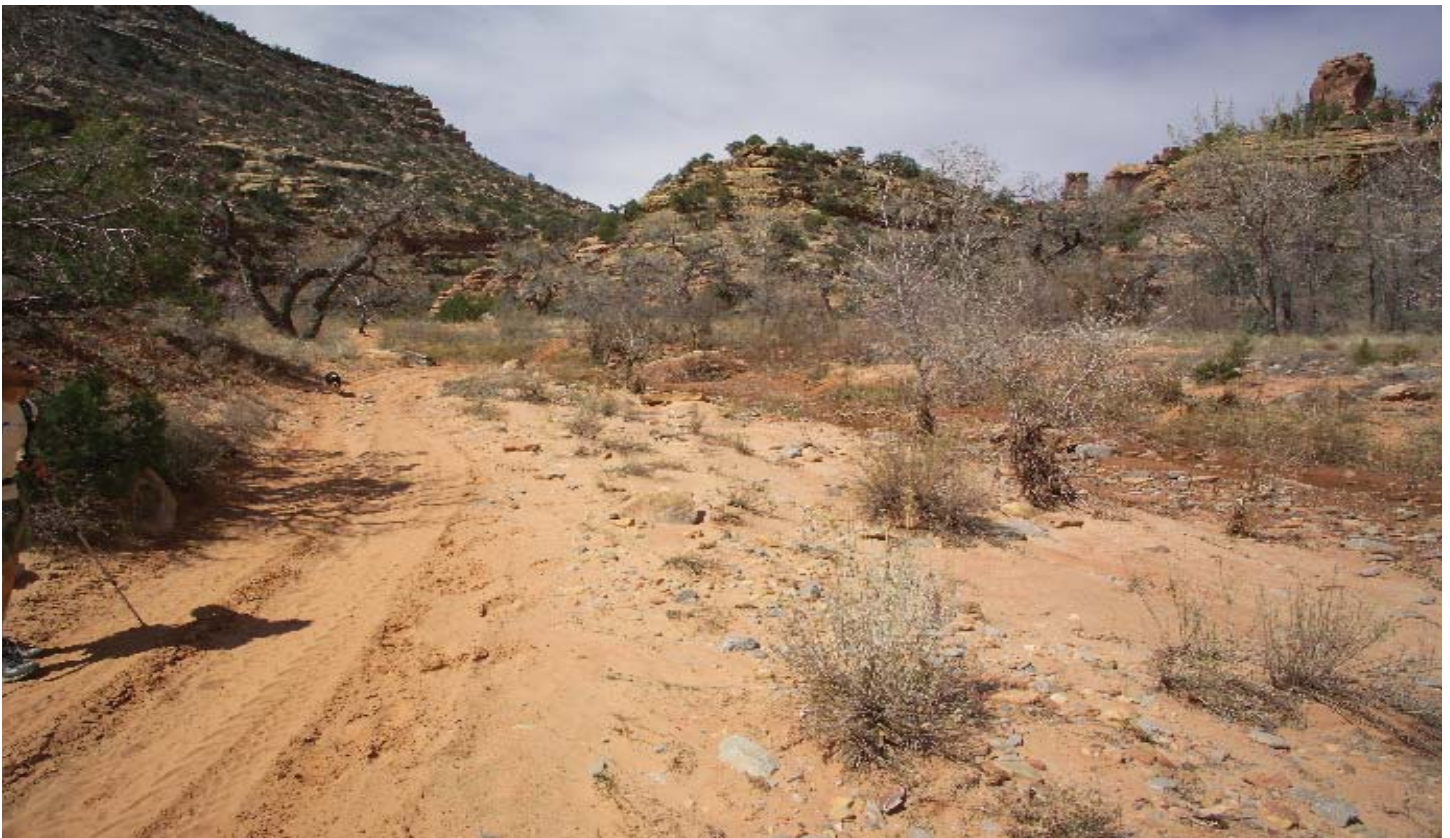
In Arch Canyon, the total canopy cover of the shrub layer, including seedlings and saplings, is in good to excellent condition in sections of the stream channel not adjacent to or crossed by the 4-wheel drive route. Shrubs, through their extensive root and above ground growth, can naturally arm themselves against large flows and greatly influence local sedimentation and flow velocity rates by increasing sedimentation and decreasing velocity. However, in many areas where erosion has destroyed the natural streambanks, there is very little shrub regeneration because the seedlings are not protected from high velocity flows. In these areas, floods consistently scour the floodplain (see **Figure 14** below).

FIGURE 14. Area where high flows and lateral cutting of vegetation and soil scour the stream channel and floodplain, reducing shrub establishment and persistence. Arch Canyon, San Juan County, Utah.

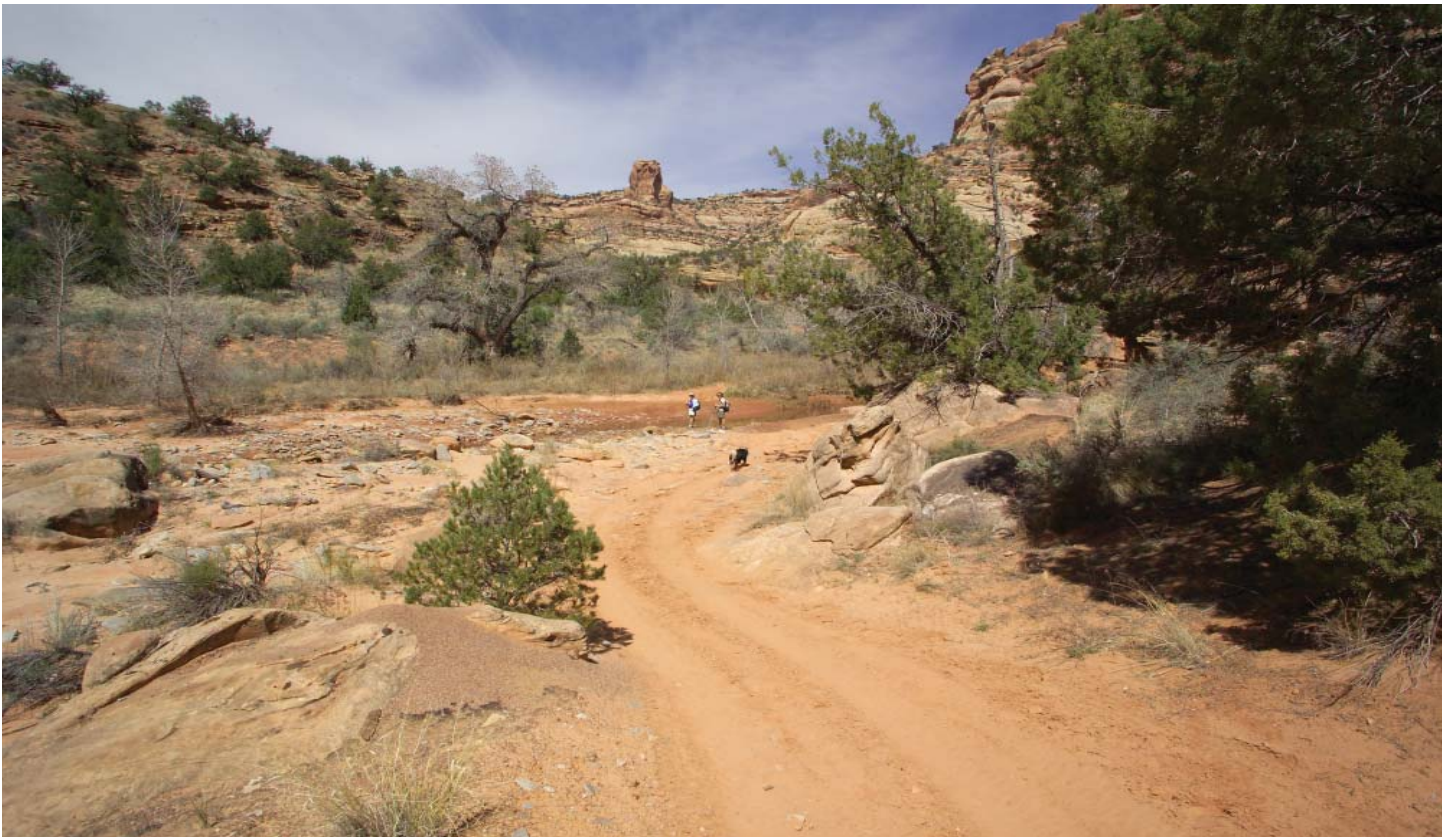
Figure 15 shows a common condition in Arch Canyon. The proximity of the 4-wheel drive route to the channel results in lateral cutting and the clearing of grasses and forbs. Throughout the study area, I estimate that 55% to 65% of the channel is covered by plant cover. This is lower than expected, resulting in denuded areas susceptible to erosion. Areas in functional condition should have at least 80-90% of the surface covered by vegetation.

FIGURE 15. Area where there is a loss of vegetation due to lateral cutting and soil erosion between the 4-wheel drive route and the channel. Area just behind the small juniper tree near the center of the photo has been almost completely denuded of vegetation due to the flow jumping onto the 4-wheel drive route in Arch Canyon, San Juan County, Utah.

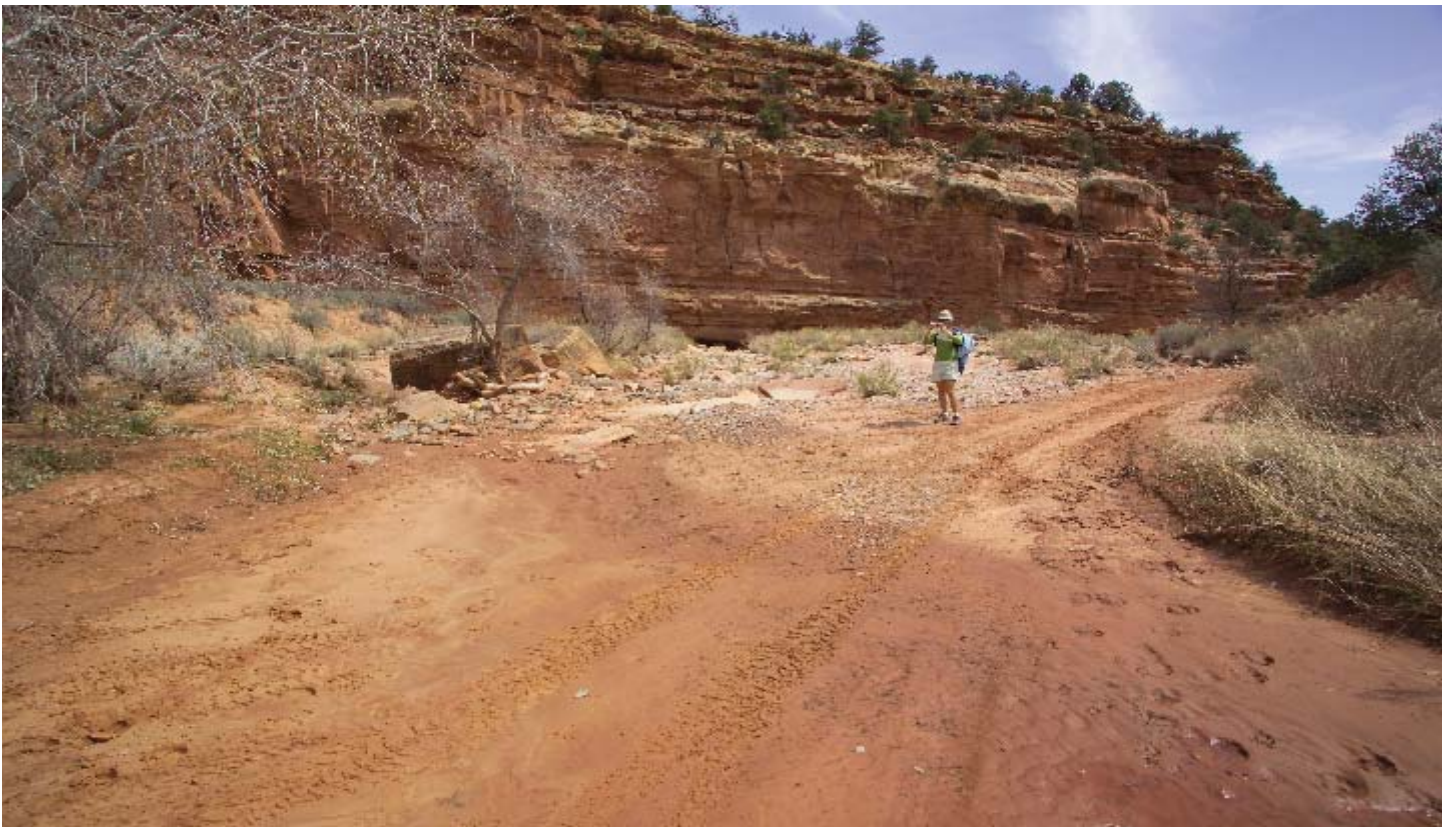
There are many sections of Arch Canyon that contain vegetation with deep binding root masses, but there are also many sections where the vegetation and/or soil has been so disturbed that these conditions do not exist. The fact that there are sections with well established vegetation indicates that this condition should be more prevalent throughout the system. If the stream channel is protected from excessive erosion and lateral cutting, the establishment of these types of plants in damaged areas would occur in time. I estimate that 55% to 65% of the stream bank in Arch Canyon contains deep binding root masses, however, all indications are that this system could support more than 85% cover of this vegetation type. In **Figure 16** there is a good cover of deep binding root mass vegetation in the lower right hand corner. This should also be the case on the bank just behind the person in the photo, but due to lateral cutting and soil scouring, the vegetation has been swept away.

FIGURE 16. Area where high flows and lateral cutting of vegetation and soil scour the stream channel and floodplain, eliminating many plants with deep binding roots. Arch Canyon, San Juan County, Utah.

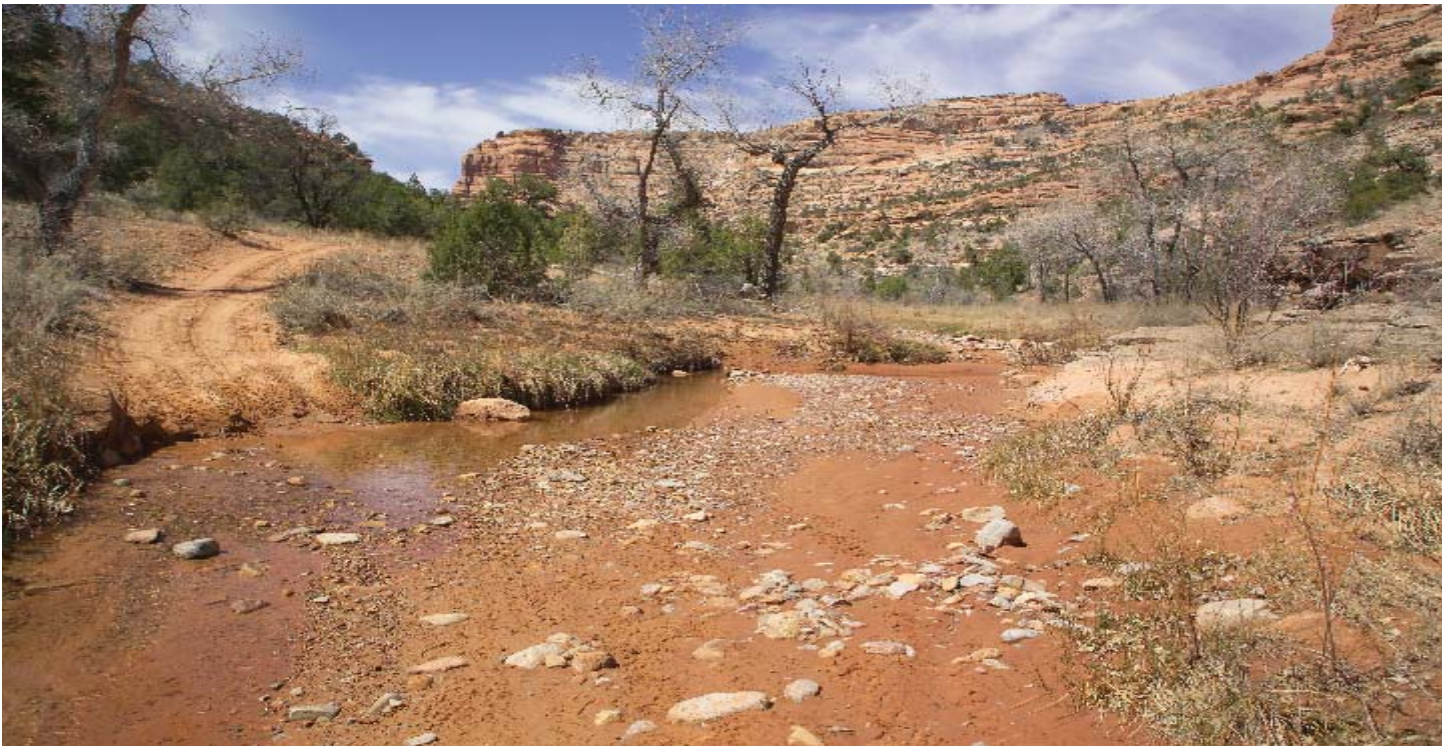
FIGURE 17. Typical pool in Arch Canyon where the flannelmouth sucker was found. Note the preference for pools with an overhanging bank and thick vegetation. Arch Canyon, San Juan County, Utah.

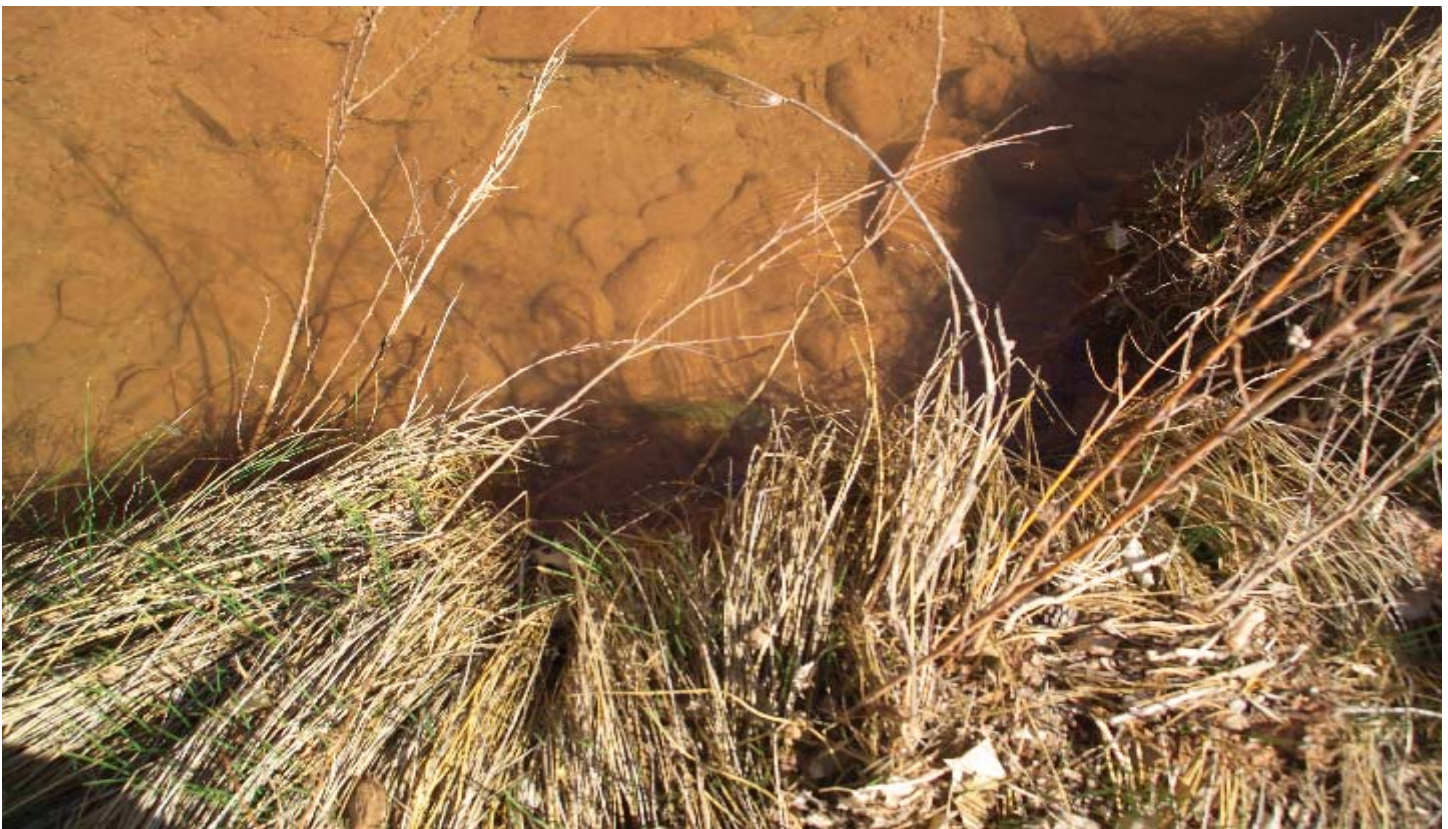
FIGURE 18. Flannelmouth sucker can be seen just above the shadow in the center of the photograph. Arch Canyon, San Juan County, Utah.

matter are also consumed. The species spawns in streams over gravelly areas during the spring and early summer. Flannelmouth suckers prefer large rivers, where they are often found in deep pools of slow-flowing, low gradient reaches. In Arch Canyon, they prefer deep pools with overhanging banks and thick vegetation. See **Figures 17 and 18** for typical habitat in Arch Canyon. This habitat is not ideal because of the loss of the overhanging streambank and vegetation on one side of the channel.

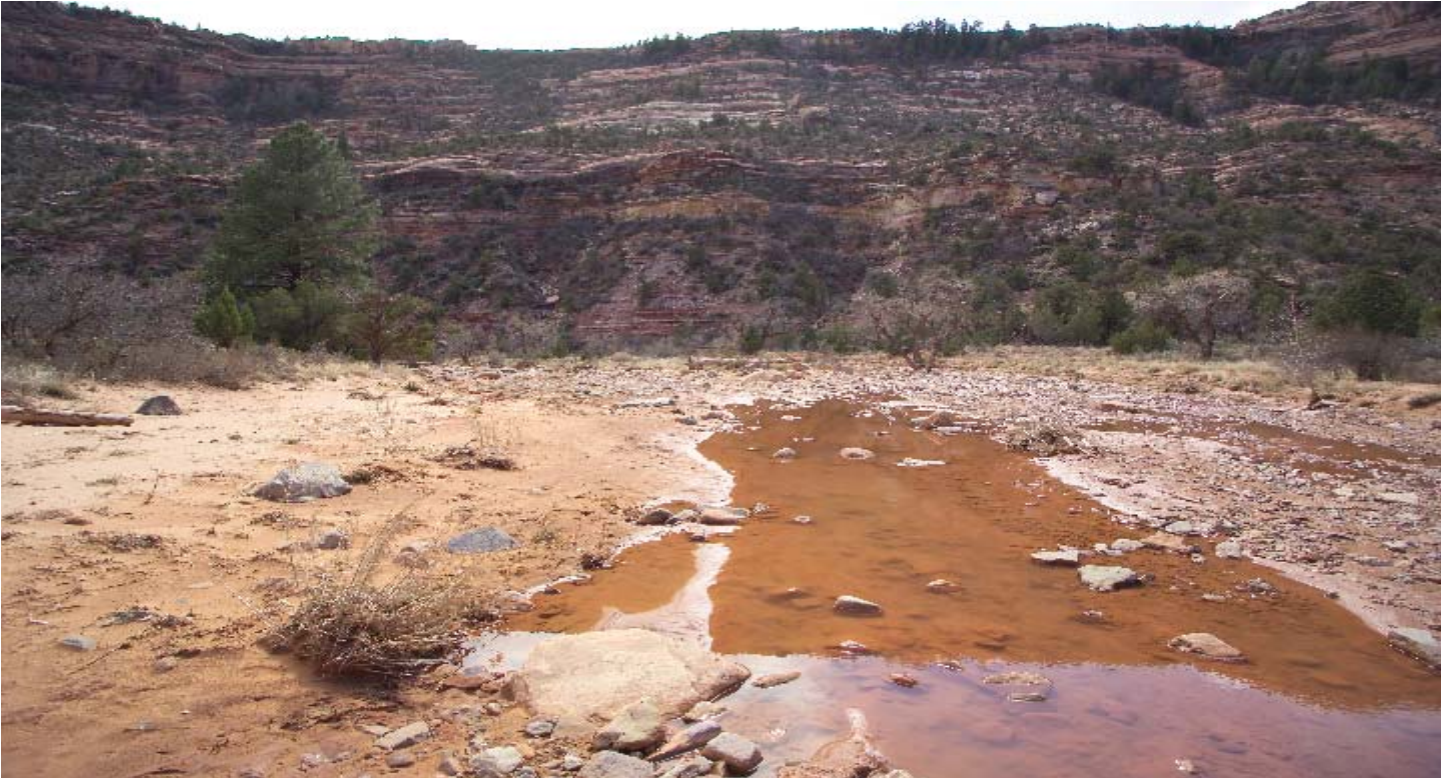
The lack of vegetation rooted in the soil next to a stream channel negatively affects several ecological functions of a healthy riparian area, including: the filtering of sediment, capturing of bedload, slowing down high water flows to decrease scouring (erosion), as well as the promotion of over bank flooding to recharge both water and nutrients in the floodplain. In addition, loss of vegetation inhibits the ability of the overall riparian corridor to support greater biodiversity. These ecological functions will continue to be impeded by the existence of the 4-wheel drive route.

FIGURE 19. View of channel just downstream of a 4-wheel drive route crossing. Note lack of vegetation, the wide channel, and loss of stream bank. Arch Canyon, San Juan County, Utah.
