**ARCH CANYON CONDITION ASSESSMENT
AND MANAGEMENT RECOMMENDATIONS**

**Report for the
Southern Utah Wilderness Association**

ECOS Consulting

August, 2006

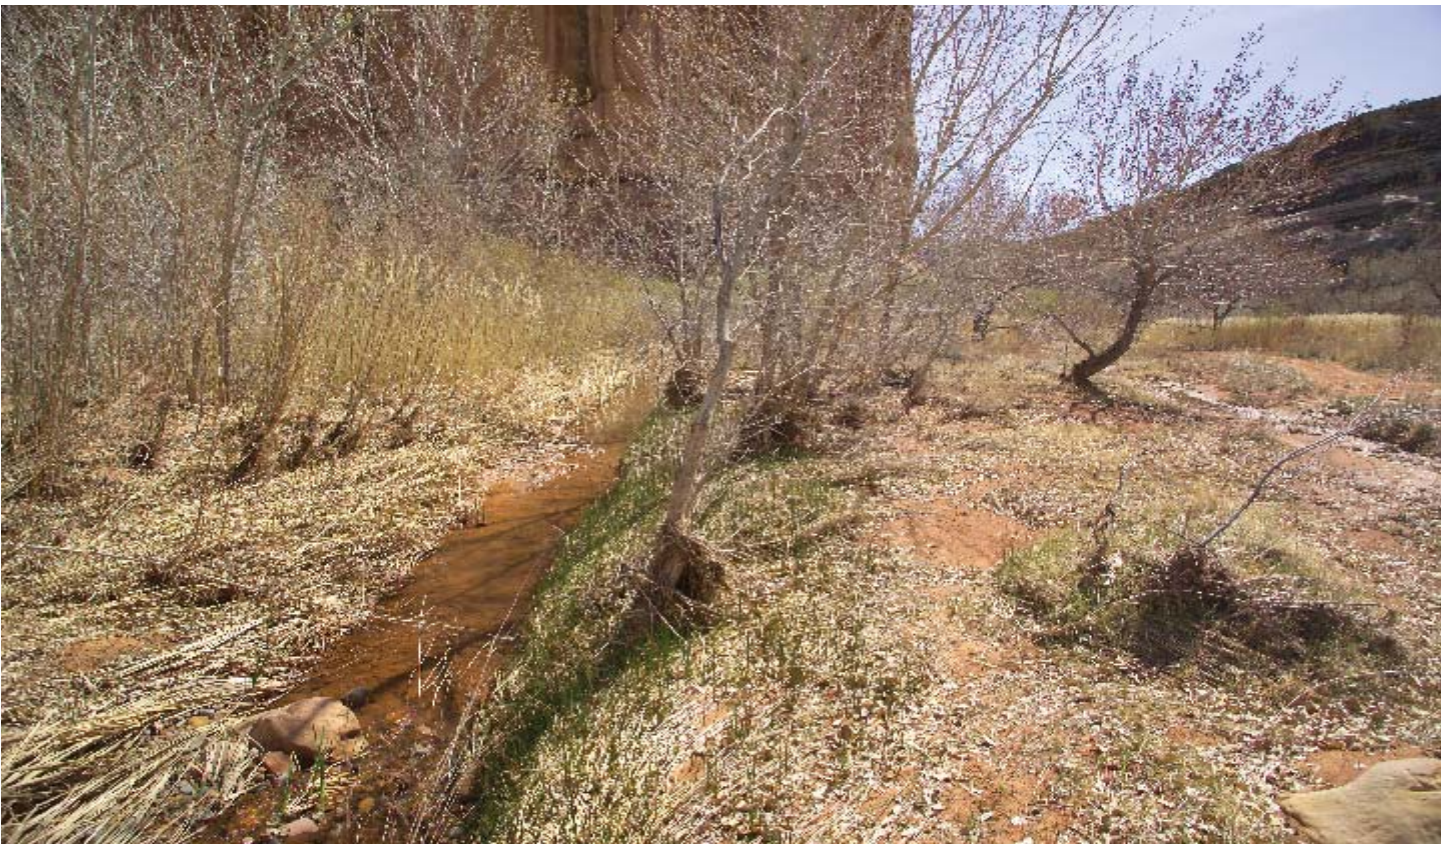
FIGURE 20. View of channel in Proper Functioning Condition. Arch Canyon, San Juan County, Utah.

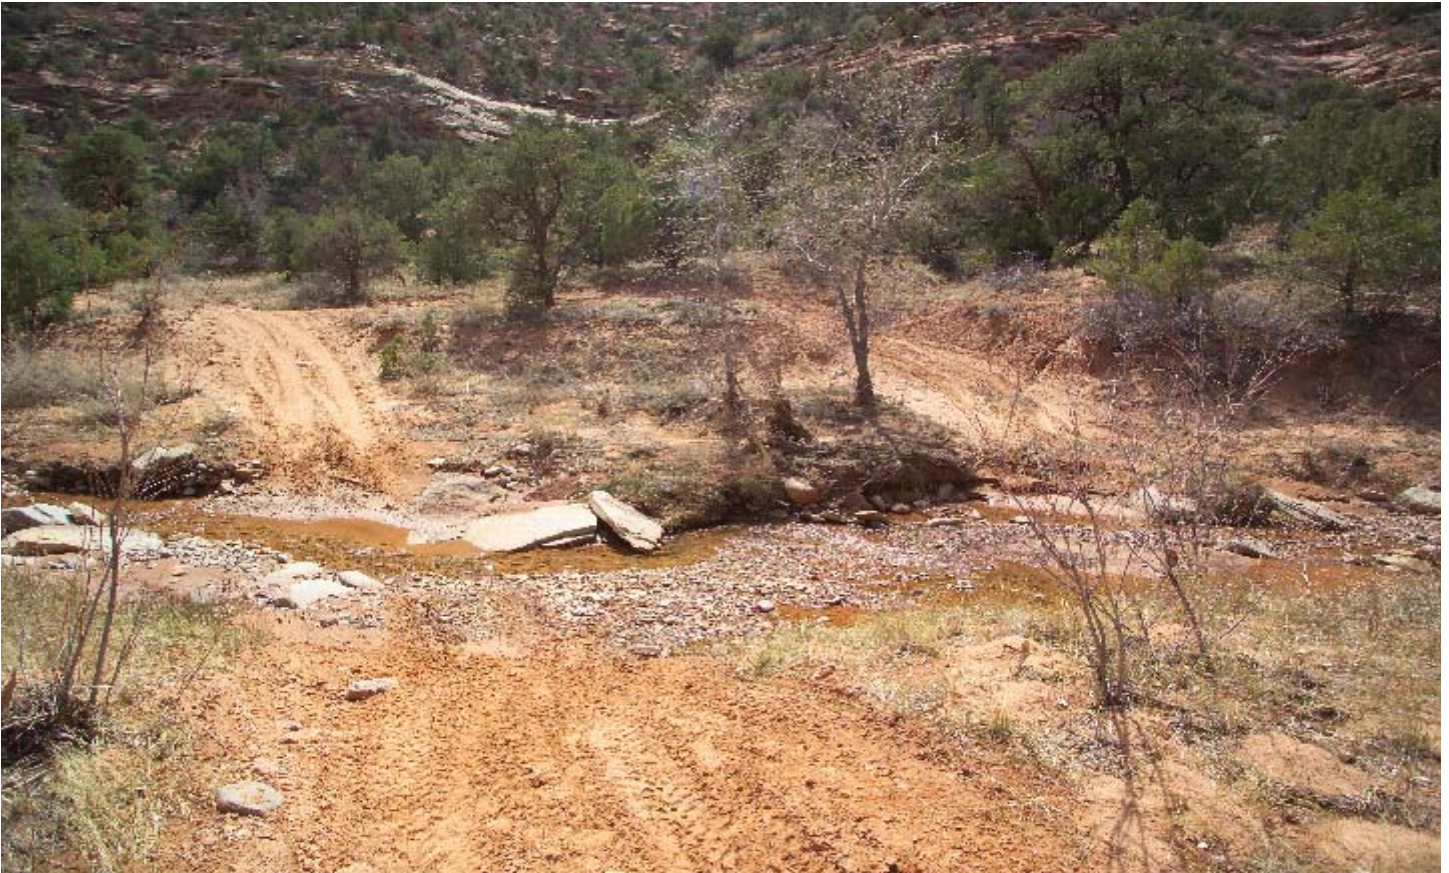
One of the critical ecological functions of a healthy riparian area is to stabilize stream banks. Motor vehicles going up and down a stream bank often swerve and cause additional damage with multiple passes, widening the bank scar. **Figure 21** on the following page shows areas where multiple routes have formed, destabilizing the streambank, degrading fish habitat, and making the area susceptible to future flood damage. There are numerous stream crossings in Arch Canyon where multiple routes have been used to climb up the streambank.

FIGURE 21. Area where multiple 4-wheel drive routes have formed; this destabilizes the streambank and makes it highly susceptible to future damage. Arch Canyon, San Juan County, Utah.

Oftentimes, stream channel erosion is initiated at a crossing due to the displacement of coarse streambed materials in the channel by the passing of vehicles. This will start the formation of a deep pool at the crossing without vegetation or rocks to armor it against high velocity flows. Once a deep sandy pool is formed drivers will avoid it by driving around it, thus creating a larger bank scar, or creating another 4-wheel drive route up the bank altogether. The total failure of numerous sections of stream bank in Arch Canyon is testament to the presence of hydrological dysfunction in the Canyon.
