**PETITION TO PRESERVE ARCH CANYON'S  
NATURAL AND CULTURAL HERITAGE**

**December 22, 2006**

### **The Resources, the Threats, and the Solution**

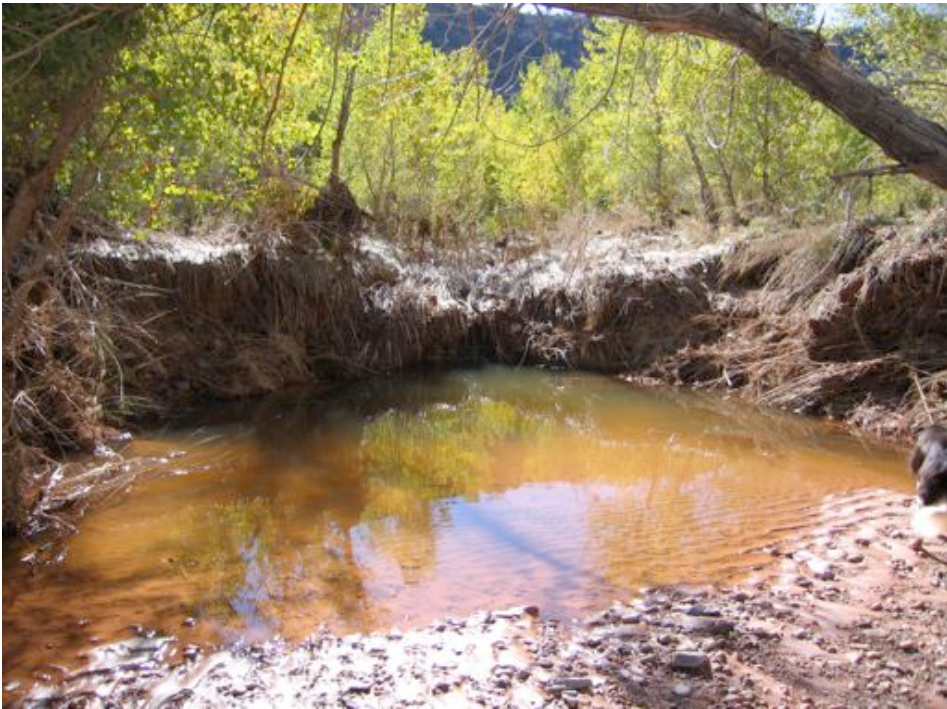
Same stream crossing (as previous photo) after large flood event in October 2006 scoured ORV route.

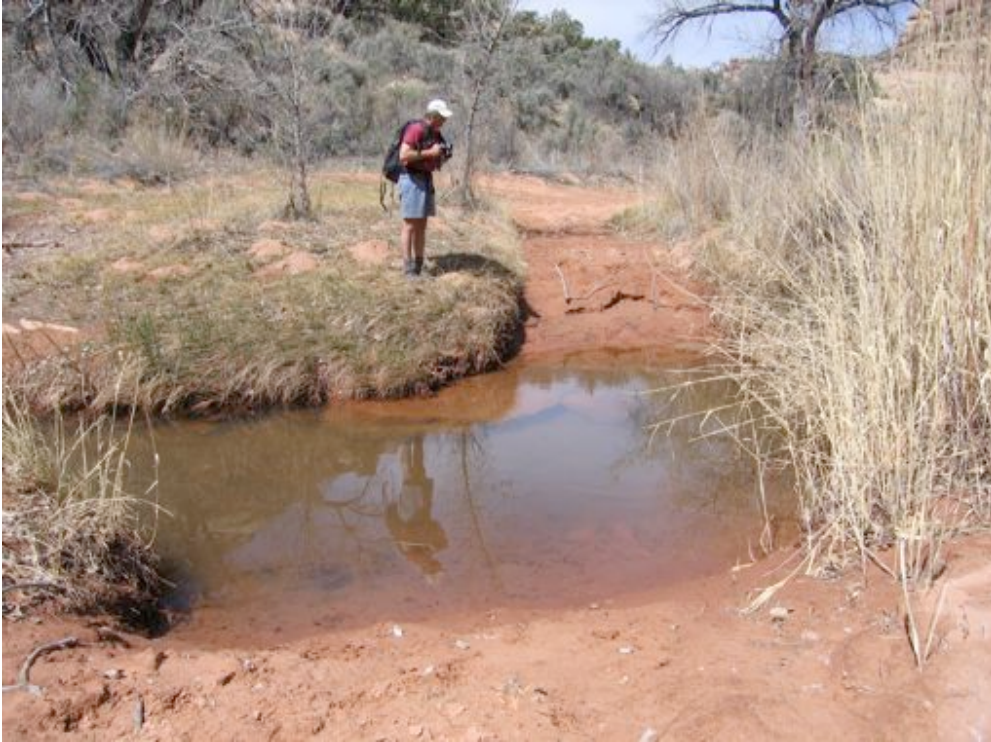
Overhanging streambank severely eroded by ORV route crossing – one of 60 crossings in Arch Canyon.

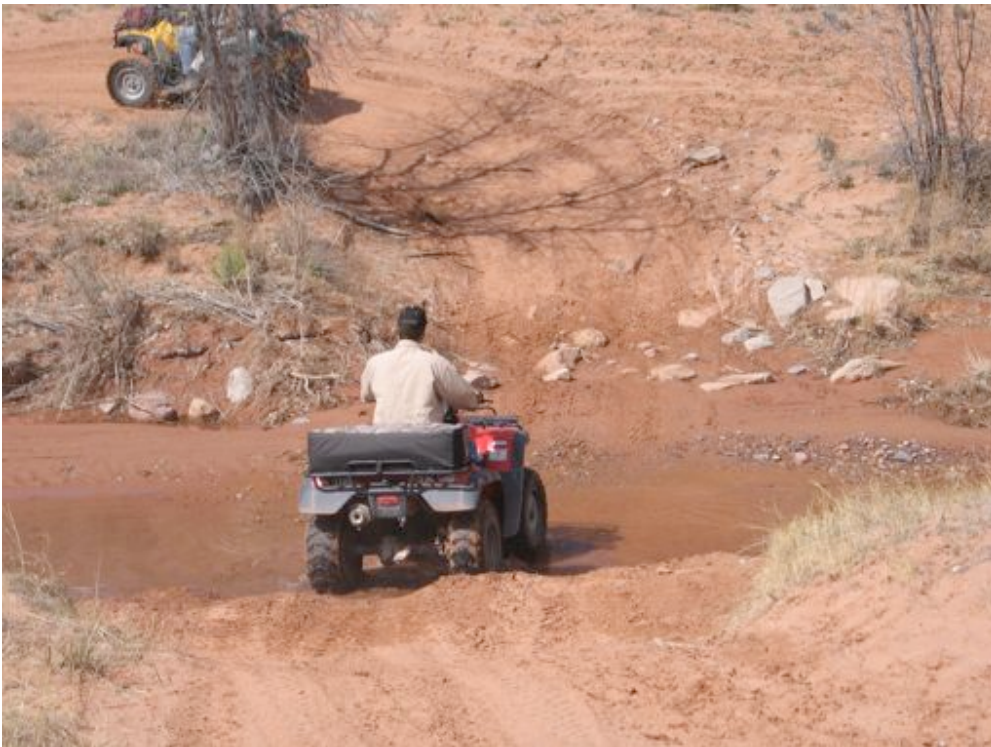
ORV route crossing stream has damaged streambank and vegetation in Arch Canyon.

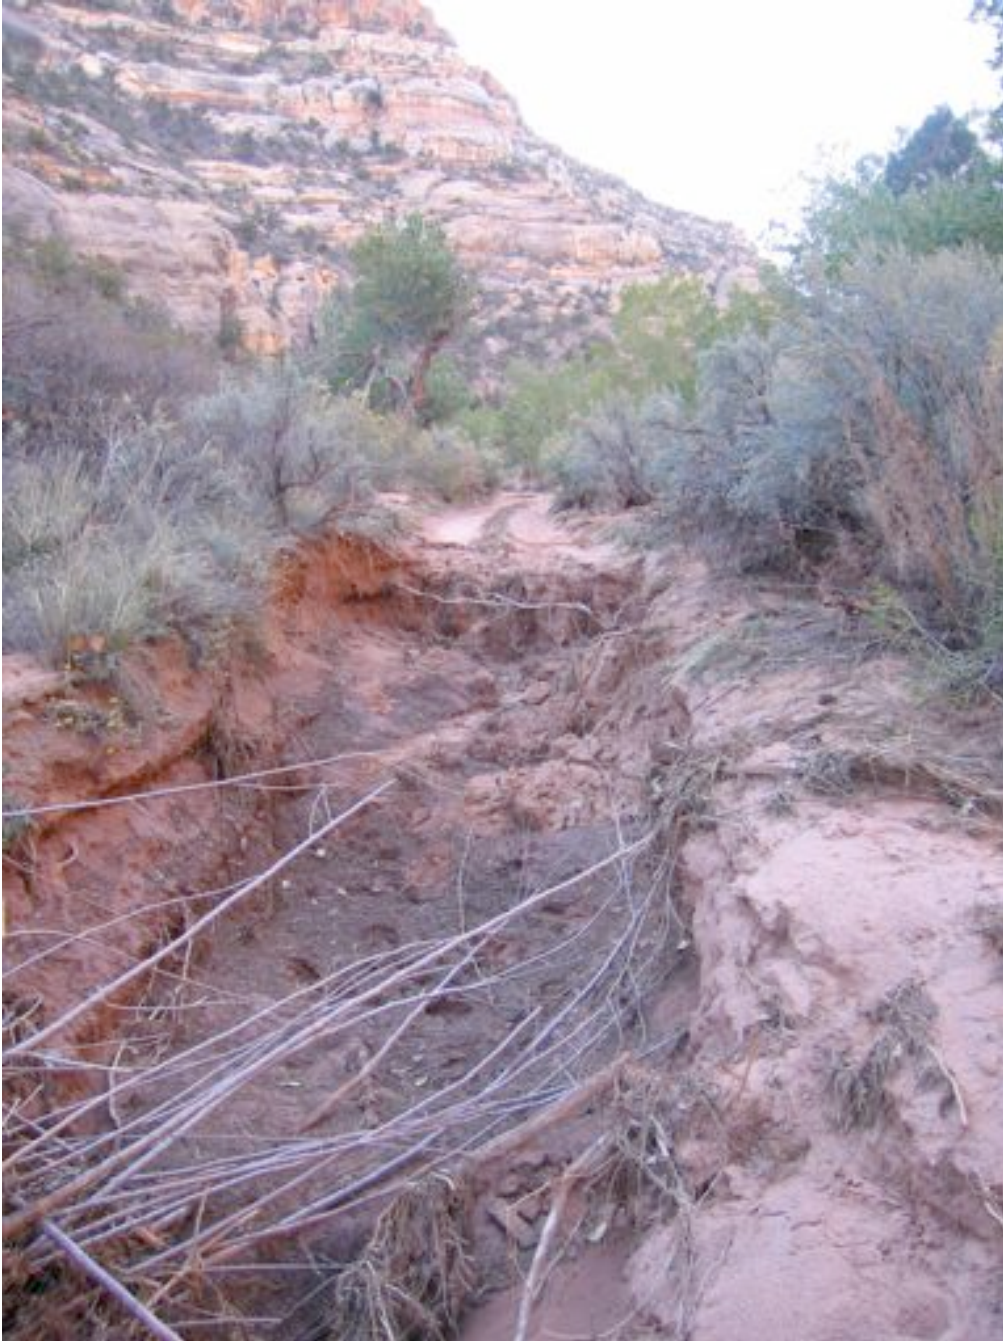
Heavy damage to floodplain due to ORV route. Floodwaters jumped from the stream channel and rather than spreading out over the floodplain, as would occur in a properly functioning system, the floodwaters were diverted by the ORV route and quickly scoured and entrenched the route - several feet deep with roots exposed. This occurred in many places along the route, contributing to a substantial increase in flow velocity and substantially more erosion.

The heaviest damage was documented in areas where the floodwaters jumped from the channel, and instead of spreading out over the floodplain, as would occur in a properly functioning system, were quickly diverted by the presence of an unvegetated and entrenched 4-wheel drive route that crosses the channel 60 times in 8.5 miles. This interception of the floodwaters by the 4-wheel drive route contributed to a substantial increase in flow velocity and energy because the waters became constricted and concentrated within the artificial channel created by the 4-wheel drive route.

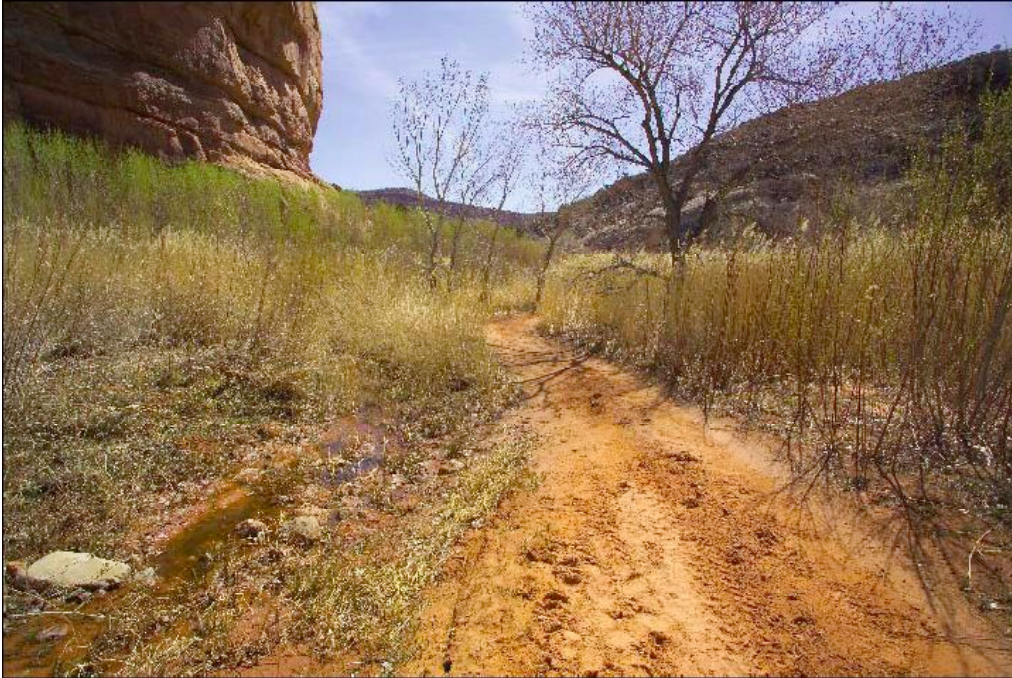
**Figure 1a.** Photo taken in April, 2006. This is a proper functioning section of the streambed in Arch Canyon. Note the thick riparian vegetation on both sides of the ORV drive route.

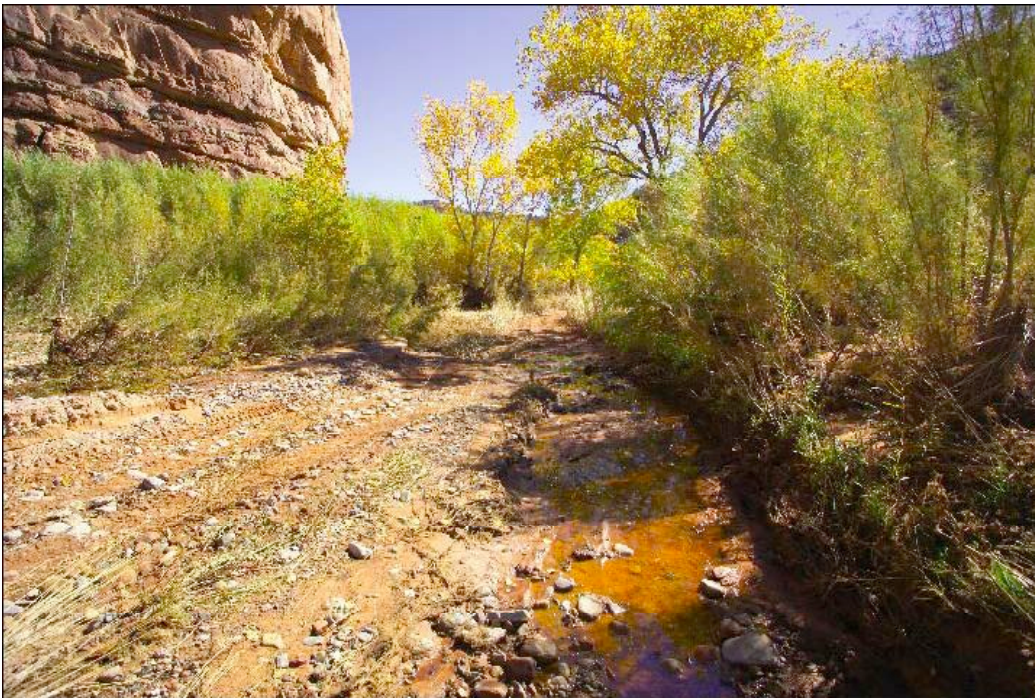
**Figure 1b.** Repeat photo of Figure 1a, taken in October, 2006. The ORV route (in center of photo) funneled water and caused extensive damage through widening and deepening around the route. Other areas with thick vegetation stayed intact.

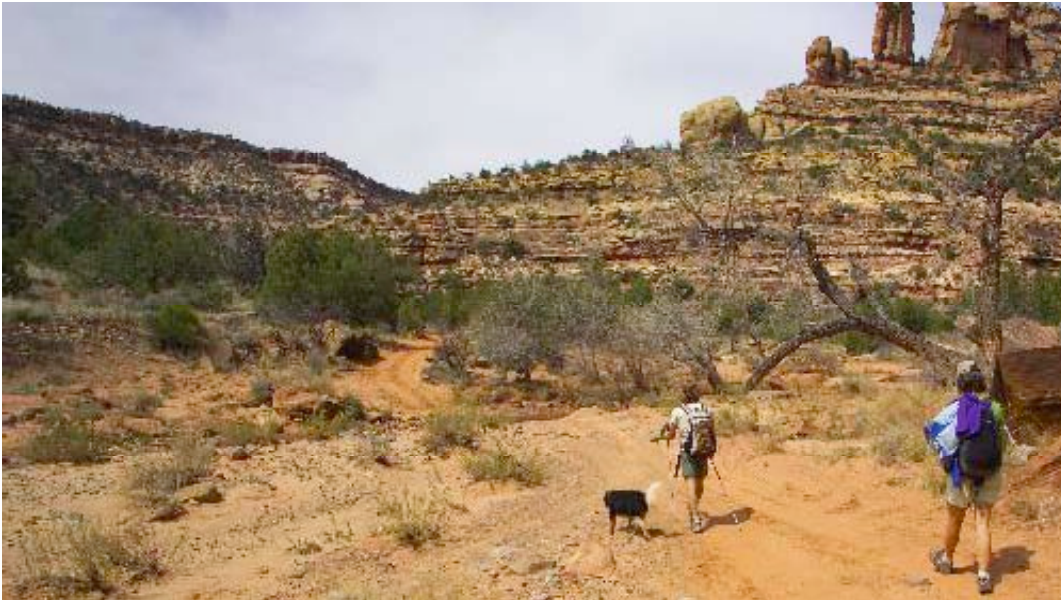
**Figure 2a.** Photo taken in April 2006. Upstream view from where ORV route exits the stream channel in Arch Canyon.

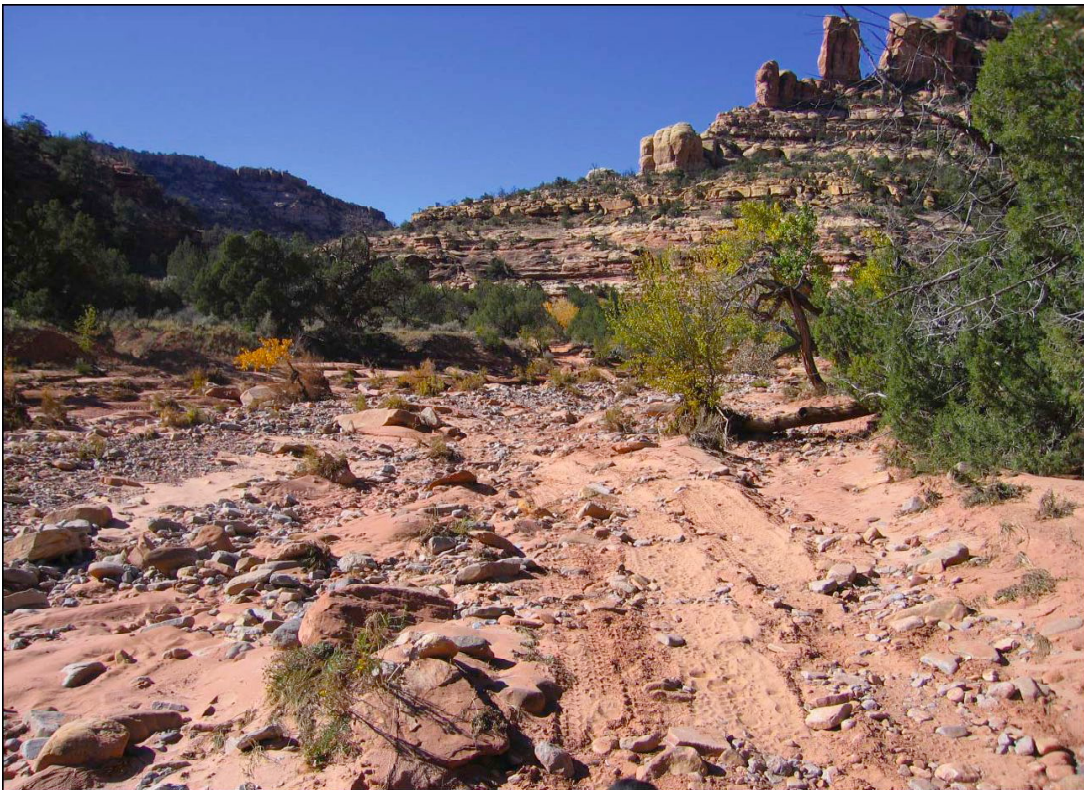
**Figure 2b.** Repeat photo of Figure 2a, taken in October 2006. Many plants have been eliminated between the ORV route and the stream channel (on the left) as flow was diverted onto the route during flooding.

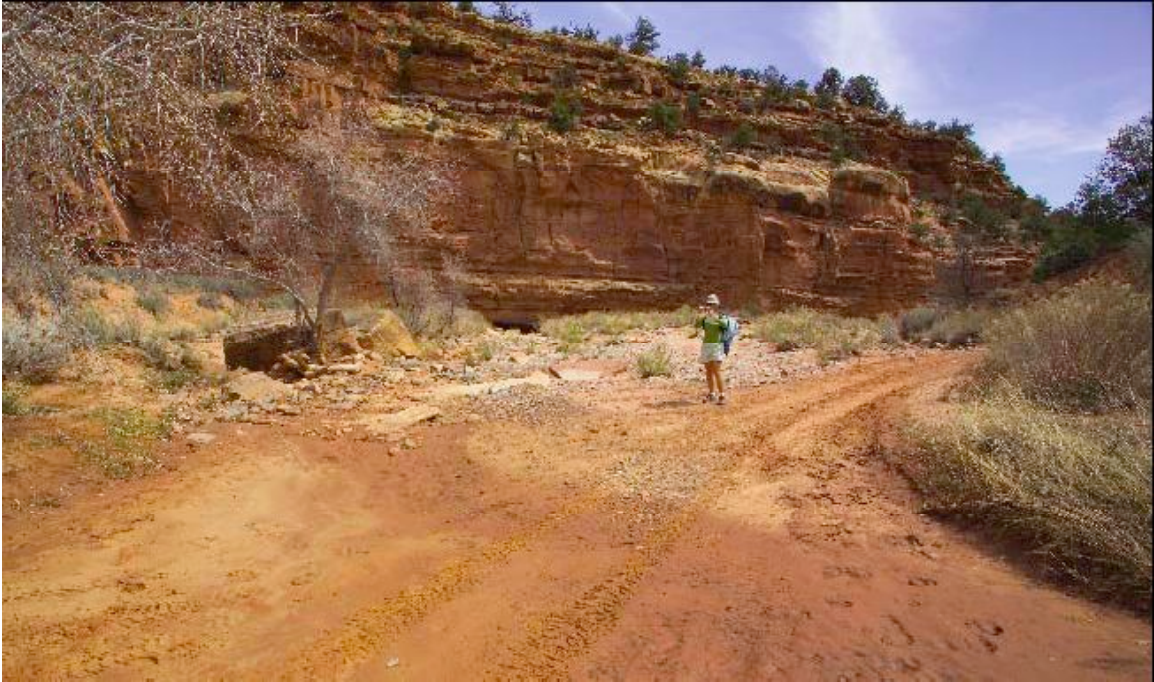
**Figure 3a.** Photo taken in April 2006. Downstream view where the ORV route crosses the stream channel in Arch Canyon.

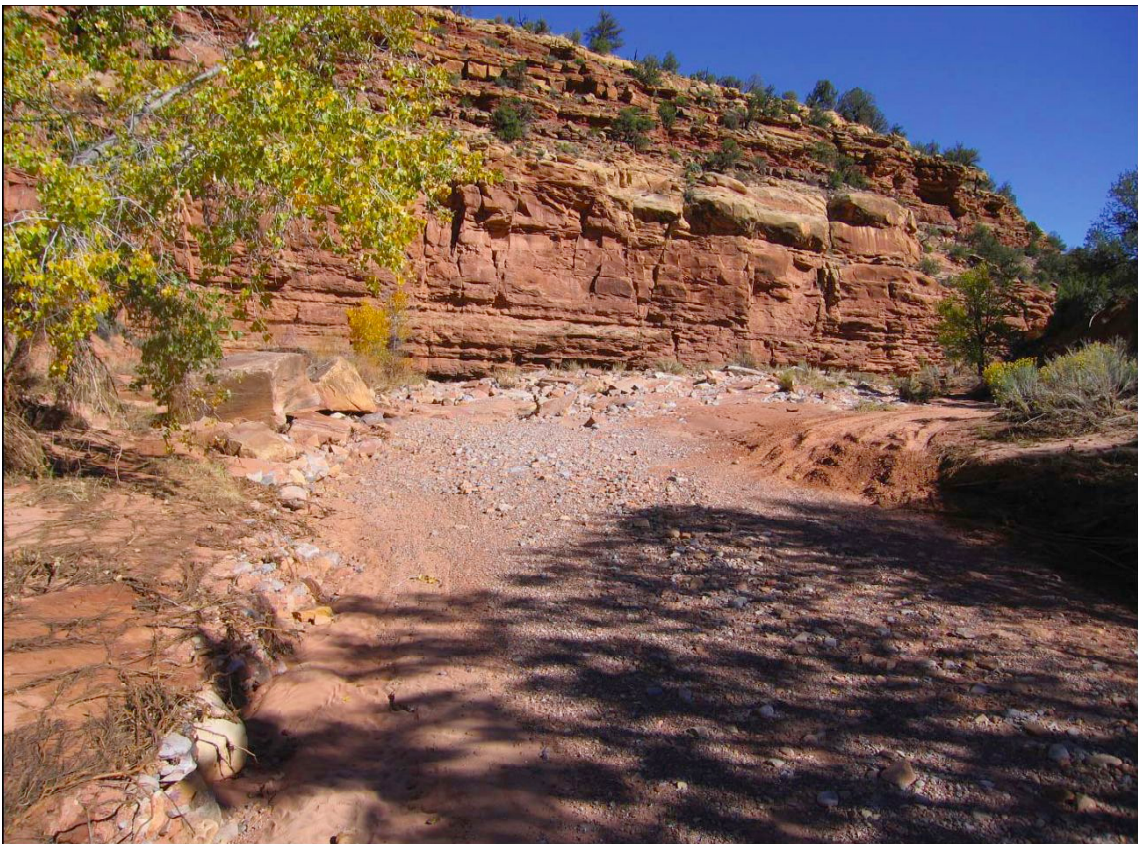
**Figure 3b.** Repeat photo of Figure 3a, taken in October 2006. Note the bank erosion and loss of vegetation along the bank on the left side and the exposed tree roots.

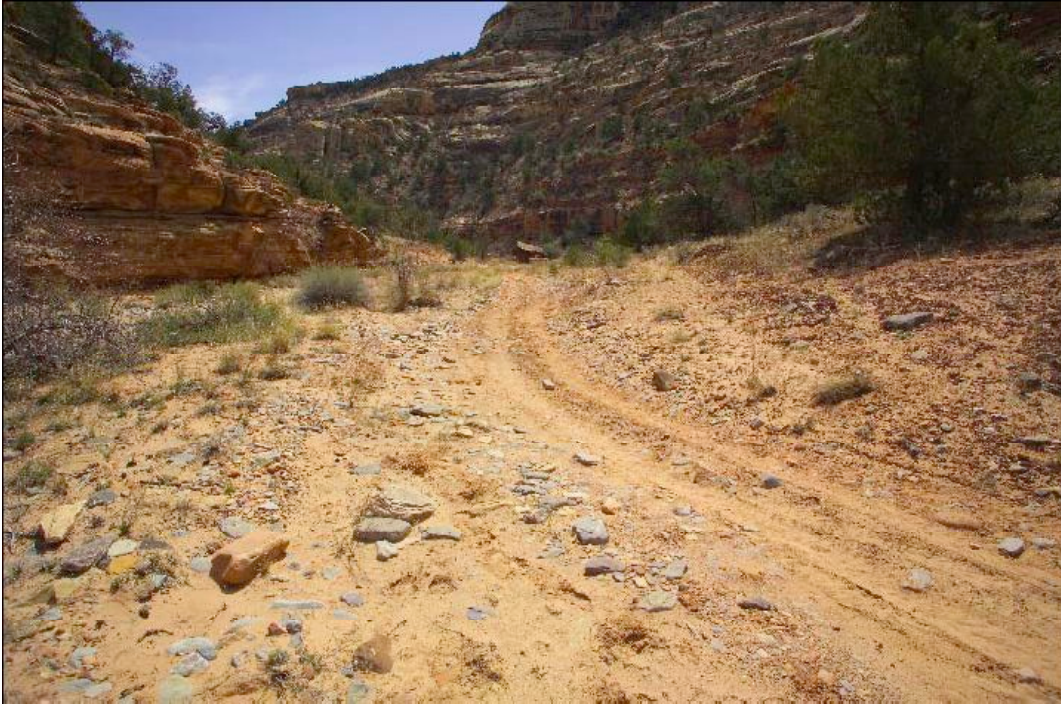
**Figure 4a.** Photo taken in April 2006. Downstream view where ORV route crosses the stream channel in Arch Canyon.

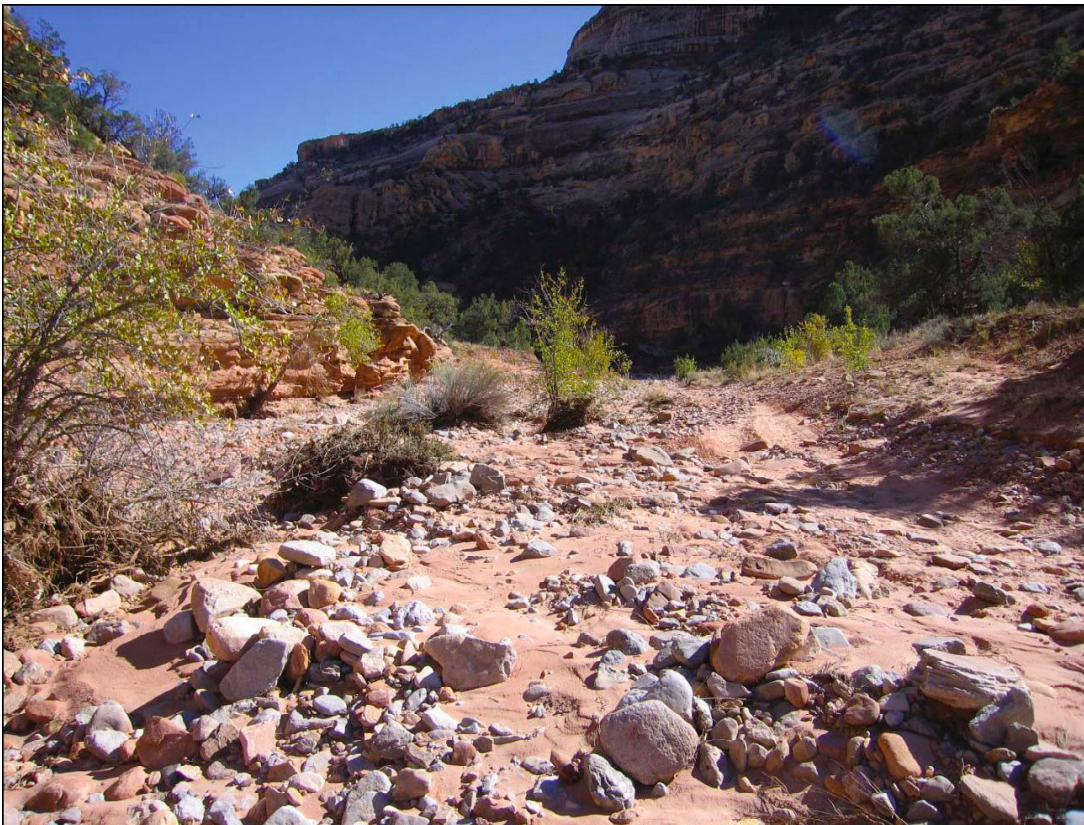
**Figure 4b.** Repeat photo of Figure 4a, taken in October 2006. Floodwaters followed the ORV route and eroded away the stream bank and vegetation between the route and the channel. Also note the erosion of soil and exposure of large rocks from the tremendous energy of the early October floods.

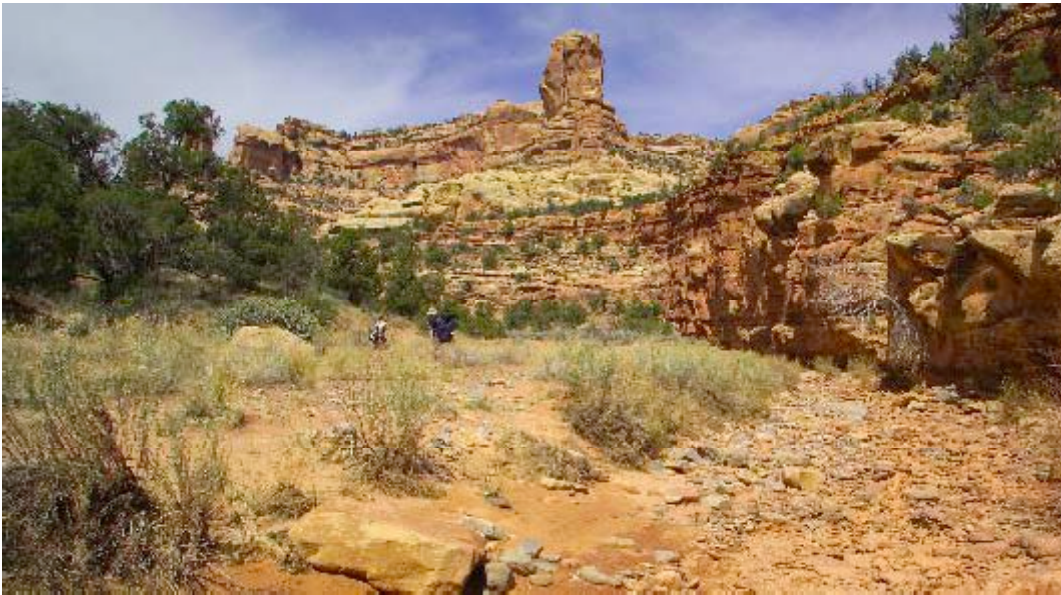
**Figure 5a.** Photo taken in April 2006. Upstream view where ORV route crosses the stream channel in Arch Canyon. People are walking on the ORV route.

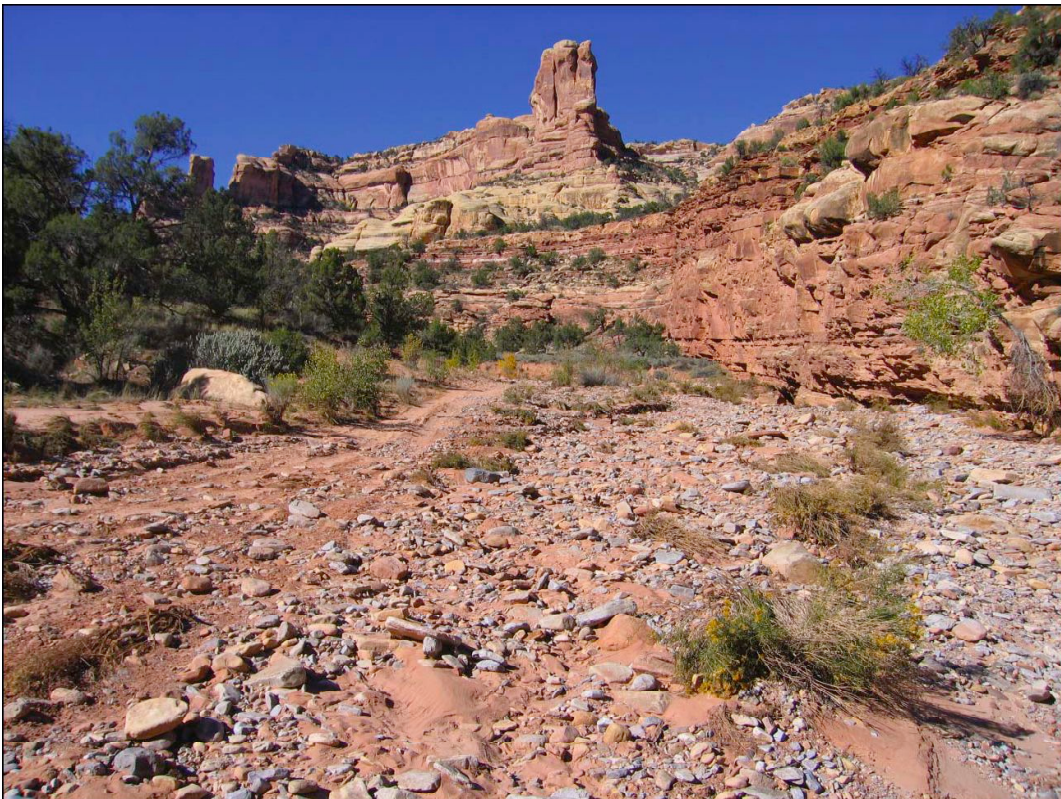
**Figure 5b.** Repeat photo of Figure 5a, taken in October 2006. Floodwaters jumped onto the ORV route and eroded away the streambank and vegetation between the route and the channel.

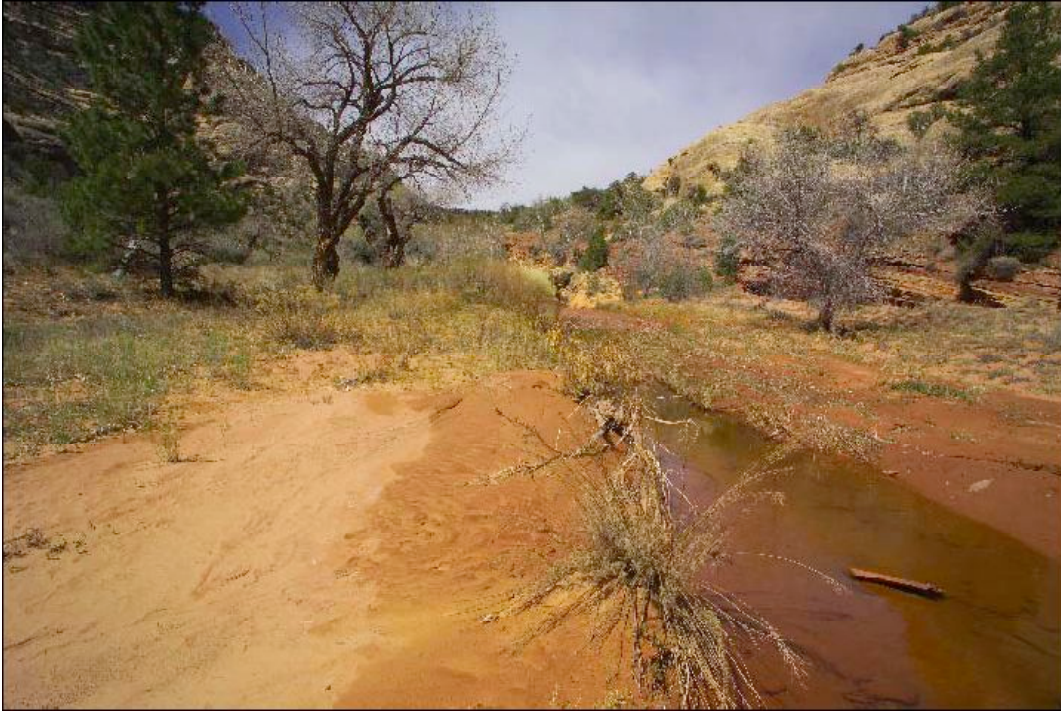
**Figure 6a.** Photo taken in April, 2006. Stream channel facing upstream in Arch Canyon; ORV route is out of sight and on left.

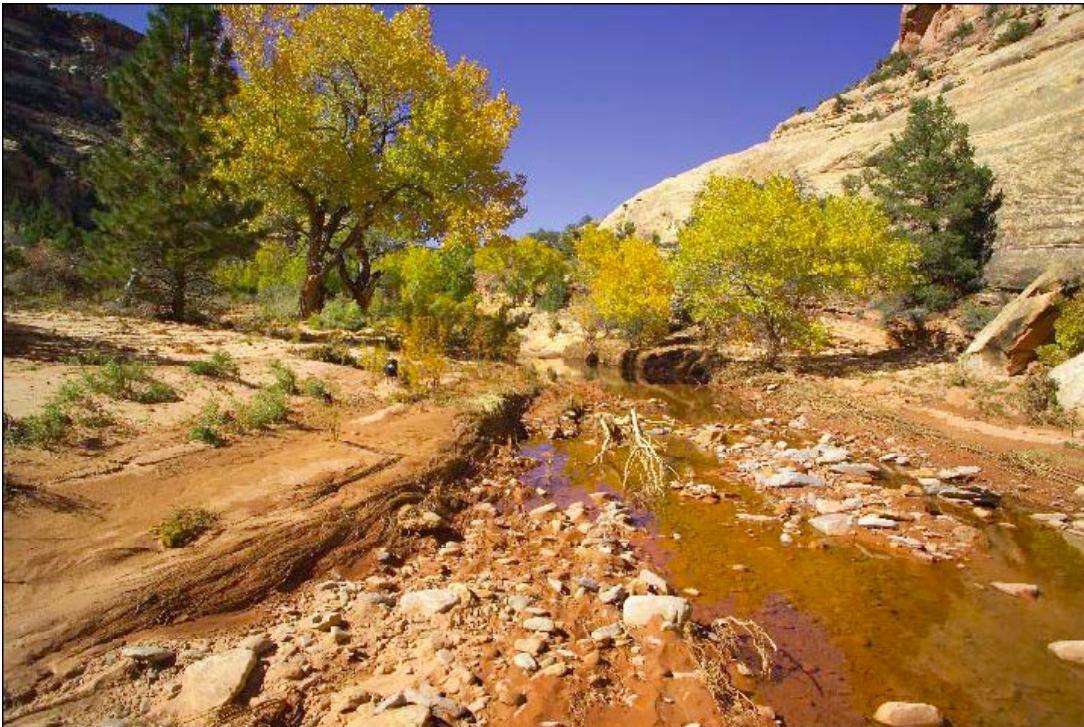
**Figure 6b.** Repeat photo of Figure 6a, taken in October, 2006. The stream channel has widened and deepened and vegetation has been eliminated.
